# Cytotoxicity of Metal Ions Released from NiTi and Stainless Steel Orthodontic Appliances, Part 1: Surface Morphology and Ion Release Variations

*Source / Izvornik:* **Materials, 2023, 16**

**Journal article, Published version**

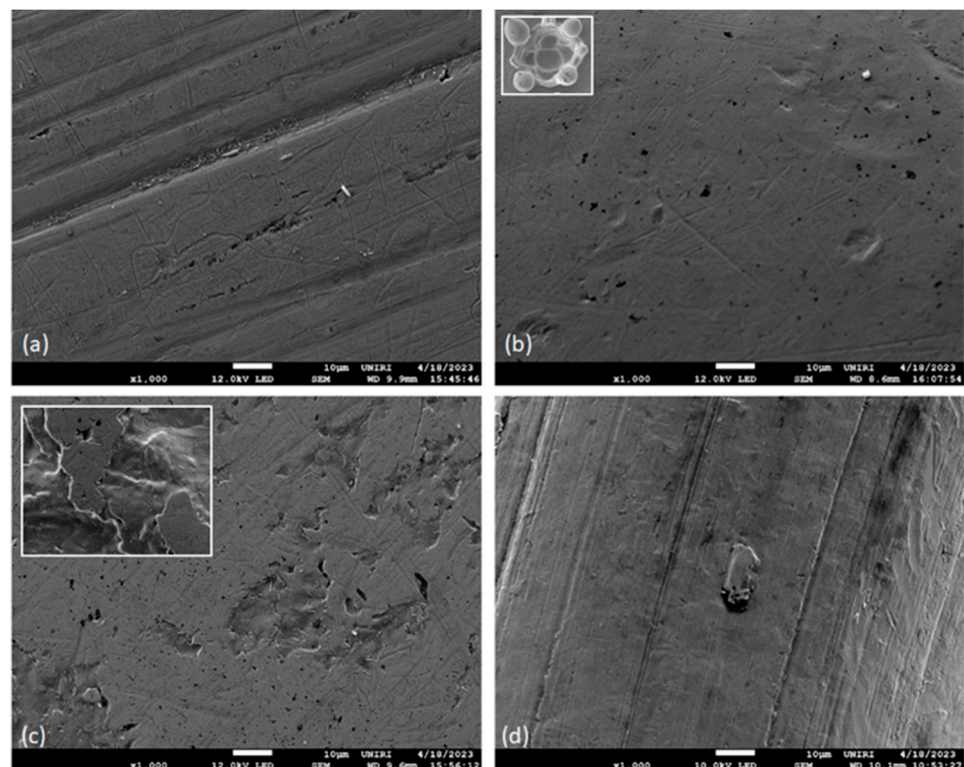
**Figure 1.** Representative SEM micrographs of (a) NiTi archwires, (b) stainless steel (SS) brackets, (c) SS bands and (d) SS ligatures, before immersion in artificial saliva.

The surface of the brackets and the bands (Figure 1b,c) contained other types of heterogeneities, most notably the black spots/pits ranging from submicron to several microns in size. The spots resembled corrosion cavities, thus indicating that the corrosion process has started before the immersion in artificial saliva. The onset of pitting corrosion on new orthodontic appliances has been reported in other studies as well [9,25]. On the other hand, no corrosion pits were noticed on the NiTi wires and ligatures, even though the ligatures were made of a very similar type of SS as the brackets (Table 1). Data obtained from the manufacturer confirmed that no coatings or additives were used on the ligatures (private correspondence); hence, the differences probably arose from variations in the manufacturing process. Indeed, it has been demonstrated that the polishing of NiTi wires to a uniform finish reduces the corrosion rate [9,26].

Alongside the corrosion pits, the brackets contained very few other morphological features, except numerous flower-like formations on the underside (depicted in the addendum in Figure 1b), arranged in a formation that reflected one of the possible shapes of the base morphology [27], with a purpose of improving the adhesion to the tooth [28]. The bands (Figure 1c) contained large, irregularly shaped cavities several tens of micrometers in size, with smooth areas in between. The lower side (the addendum in Figure 1c) contained a markedly smaller proportion of smooth areas. The differences between the two sides, also visible macroscopically, are the result of intentionally lower polishing level of the lower side, again to improve the adhesion to the tooth.

The SEM micrographs also showed that all parts except the ligatures contained small amounts of approximately micrometer-sized white crystal deposits. Similar impurities were found in other studies, located in the corrosion pits [25] or elsewhere on the surface [29].

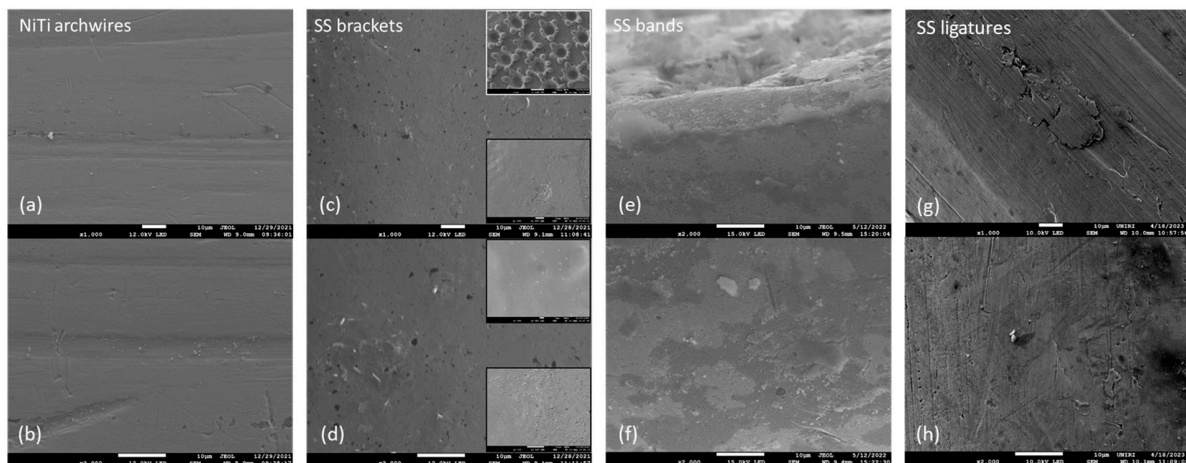
**Figure 2.** Representative lower magnification (top row) and higher magnification (bottom row) SEM micrographs of (a,b) NiTi archwires, (c,d) stainless steel brackets (SS), (e,f) SS bands, and (g,h) SS ligatures, after 3 days of immersion in artificial saliva.

Three days of immersion did not notably enhance the pitting corrosion in SS brackets, nor did it result in deposits or adherent material. However, the protrusion of crystal clusters from the bulk was observed. Higher magnification images (representative image given as upper addendum in Figure 2d) further indicated that the small white entities were not the adhering material. Besides those, the lower bracket surface, containing areas of various morphologies (addendums in Figure 2c,d), also showed no notable changes.

On the contrary, the SEM micrographs of SS bands (Figure 2e,f) showed prominent changes and a very small portion of the unaffected surface. Most of the surface was covered with an adherent layer that was not detected on other parts of the fixed appliance. This layer can be recognized as an oxide protective layer, which is common on SS products [30–33]. Lighter colored deposits were observed on the top of the protective layer and in the areas in between, which were reminiscent of layer debris [34].

Black pits were visible on the surface of SS ligatures (Figure 2g,h), indicating the onset of corrosion. An increased number of white crystal precipitates was also observed.

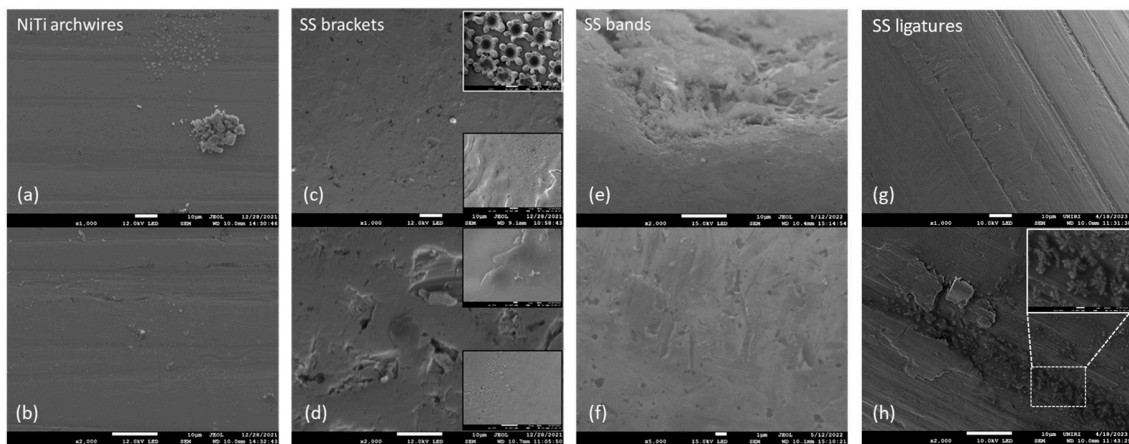
**Figure 3.** Representative lower magnification (top row) and higher magnification (bottom row) SEM micrographs of (a,b) NiTi archwires, (c,d) stainless steel brackets (SS), (e,f) SS bands, and (g,h) SS ligatures, after 7-day immersion in artificial saliva.

After 7-day immersion, no signs of localized corrosion or oxide layer formation were observed on the NiTi surface (Figure 3a,b). The quantity of deposits increased, both in number and size.

SEM micrographs (Figure 3c,d) indicated changes on the surface of SS brackets. Two main features were observed on the upper surface: the large amount of irregularly shaped large cavities ( $>10\ \mu\text{m}$ ) and large, regularly shaped crystal deposits, up to  $10\ \mu\text{m}$  in size. The lower surface appeared to be less affected, as indicated by the addendums on Figure 3c,d. The amount and the size of the corrosion pits appeared similar to those observed after 3-day immersion.

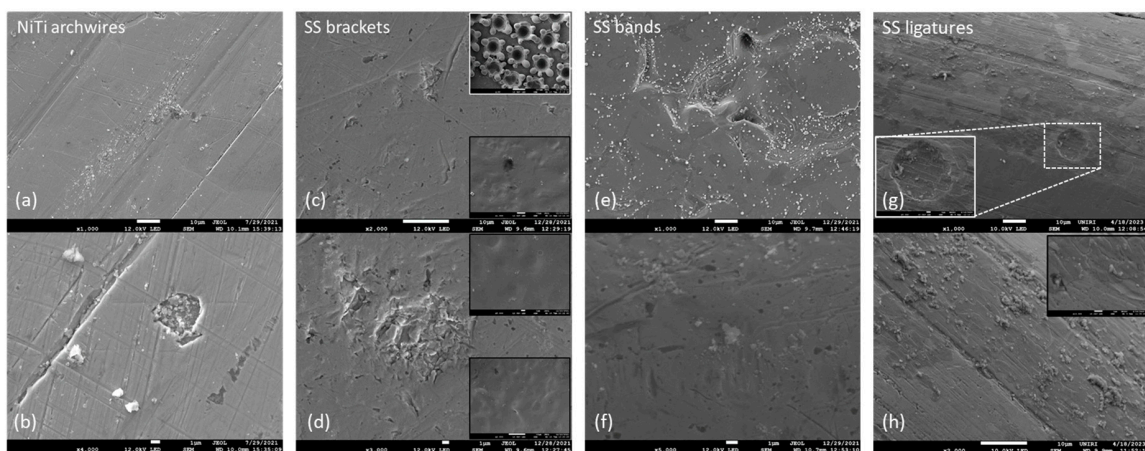
**Figure 4.** Representative lower magnification (top row) and higher magnification (bottom row) SEM micrographs of (a,b) NiTi archwires, (c,d) stainless steel (SS) brackets, (e,f) SS bands, and (g,h) SS ligatures, after 14-day immersion in artificial saliva.

After 14-day immersion, development was observed on the surface of the NiTi archwires (Figure 4a,b). New crevices and grooves were formed, and the surface—both on the inside and the outside of the surface irregularities—was abundant with white precipitates/deposits of various sizes. No signs of pitting corrosion were observed.

Pitting corrosion appeared to be slightly advanced on the SS bracket surface (Figure 4c,d), but this should be confirmed by quantitative methods. For comparison, Frois et al. [31] found no relevant morphological changes on the surface even after 30 days of immersion. New deposits of specific morphology formed, having a size of a few tens of micrometers. Larger white crystal deposits were rare and located on the underside of the bracket (addendums Figure 4c,d). Deposits also occurred on flower-like structures (upper addendum on Figure 4c).

Results for the SS bands showed a drastic increase in the number of white precipitates (Figure 4e). The protective layer (Figure 4f) appeared similar to that observed after 7-day immersion (Figure 3f).

The surface of the ligatures changed: irregular patches were observed, indicating the formation of the protective layer (Figure 4g,h). Large amounts of debris and precipitates were present, and located on the top of the protective layer, not on the unaffected areas.

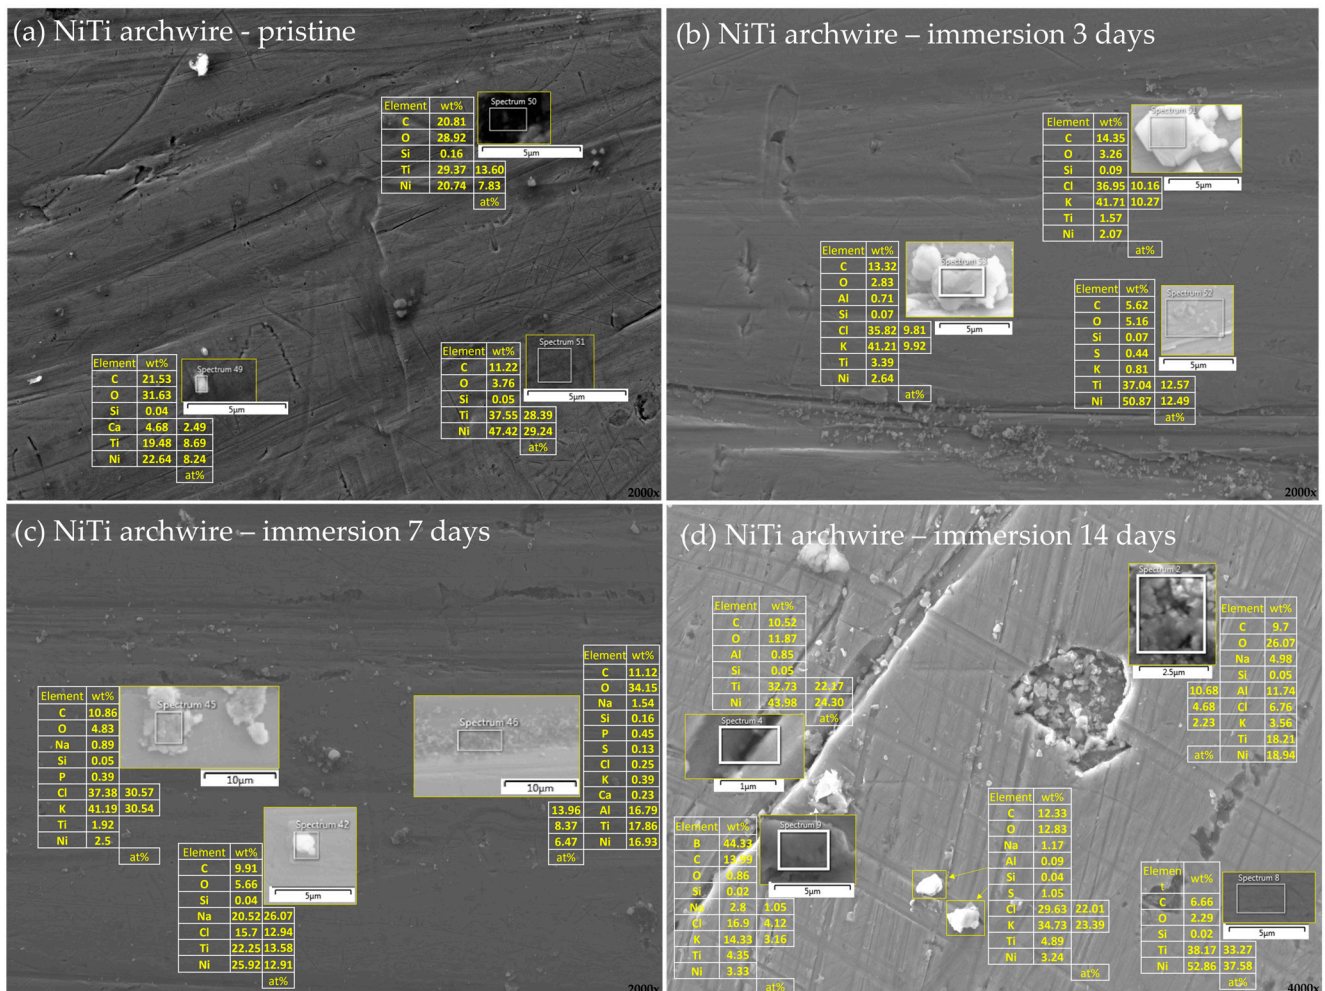
**Figure 5.** Elemental analysis of the archwire surface in an (a) as-received state and after (b) 3 days, (c) 7 days, and (d) 14 days of immersion in artificial saliva. Smaller images show a magnified view of representative surface areas/deposits/precipitates seen in the background image. The tables next to the smaller images show the respective elemental compositions, expressed as wt% for all the elements and at% for those most relevant. In the right corner of every part of a figure is a magnification.

Representative results for the surface of the NiTi archwire are shown in Figure 5. The elemental composition of the smooth unaffected regions (e.g., Spectrum 51, Figure 5a; Spectrum 52, Figure 5b; Spectrum 8, Figure 5d) showed that the ratio of Ni and Ti atomic percentages in these regions was approximately 1:1, indicating that in those areas the surface composition reflects the nominal composition of the alloy (Table 1). Moreover, comparing the relative amounts of Ni and Ti with oxygen for those locations, a very low oxygen level can be observed. Correlating this result with, for example, those reported in a study by Carroll and Kelly [5], it can be inferred that the typical oxide layer [23,24,29,38–41] did not form. This is also in accordance with the SEM results, where the protective layer would be visible due to its specific texture [24]. Note that the results showed that the oxide layer did not form even after 14-day immersion (sp. 8, Figure 5d). As indicated by SEM and confirmed by EDX, the NiTi wires used in this study were obviously depleted of the protective oxide layer, which is done by mechanical polishing [5]. Devices with a mechanically and electrolytically polished NiTi surface are also used as implants [29]. The studies showed that the prevention of Ni release by a thick oxide layer can be inadequate because it led to Ni accumulation below the protective layer, which served as a reservoir for Ni release in the case of surface damage, and led to the onset of pitting corrosion [29,42]. It has been shown that polished NiTi surfaces exhibited improved resistance to localized corrosion attacks in a chloride-rich medium [6].

On some locations, the 2:1 atomic ratio of Ti and Ni was found (sp. 50, Figure 5b). This result implied the formation of  $Ti_2Ni$  phase, which typically occurs in NiTi wires [19,38,43,44]. Increased carbon content was observed in some locations, which could theoretically indicate the formation of the titanium carbide [38,41,45,46], but it is less likely due to the above-given reasons regarding carbon measurements with EDX. The dark grains of pure Ti, observed in some studies [6], were not found in our samples.

EDX analysis also revealed that the large crystallites observed on the NiTi surface consisted of equimolar amounts of K and Cl (sp. 51 and 53, Figure 5b; sp. 45, Figure 5c and yellow squared parts, Figure 5d), indicating the precipitation of potassium chloride crystals. In some cases (sp. 9, Figure 5d), the results implied that part of the  $K^+$  ions was exchanged with  $Na^+$ . Potassium chloride is a highly soluble salt (~39 g per 100 g  $H_2O$  at 37 °C) and was observed only on samples after immersion; hence, it can be inferred that the crystals formed after the evaporation of artificial saliva. Eliades et al. [47] reported the formation of microcrystalline KCl and NaCl deposits as well, on the surface of NiTi wires taken after 1–6 months in vivo, which substantially altered the surface composition and topography. Note that the artificial saliva used in our study contained potassium chloride and other potassium and sodium salts (vide supra, Section 2.2).

The crystals on the as-received NiTi samples contained elevated amounts of calcium ions (sp. 49, Figure 5a), accompanied by relatively high amounts of C and O, which might suggest the formation of calcium carbonate. Alongside large white precipitates, other types of deposits could be distinguished. The EDX analysis of smaller gray entities (<0.5  $\mu m$ ), distributed over wide areas as clusters or individually, showed equimolar amounts of Ni and Ti (sp. 52, Figure 5b) with low oxygen content, confirming them as manufacturing debris. Calcium phosphate deposits, found in previous studies after NiTi immersion in phosphate-containing solutions [6,23,48], were not detected on our samples.

Elemental analysis also showed that some of the small crystal clusters contained appreciable amounts of aluminum (e.g., Spectrum 46, Figure 5b; Spectrum 2, Figure 5c), accompanied by an increased amount of oxygen, indicating a possible formation of aluminum oxide (alumina). This result is noteworthy because aluminum was not listed in the nominal alloy composition. Yet, in several studies, some amounts of Al were found on the surface of the as-received samples [41], among the released ions in the artificial saliva and in the artificial saliva itself [49], and in the surface precipitates [25]. Moreover, Gravina et al. studied the composition of NiTi wires from six different companies and found  $Al_2O_3$  in all

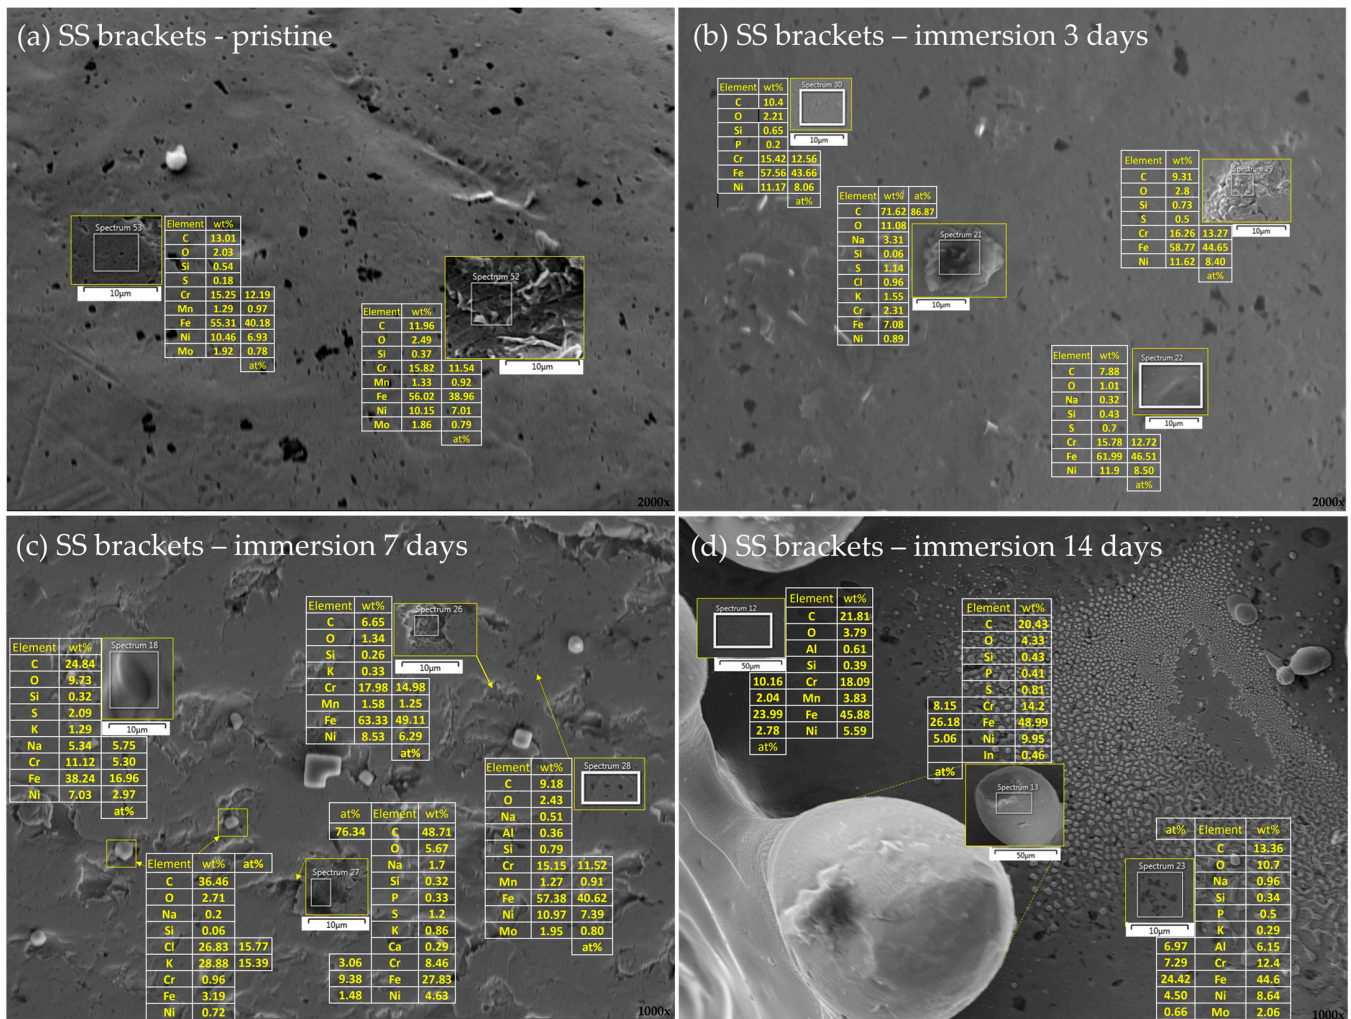
**Figure 6.** Elemental analysis of the bracket's surface in an (a) as-received state and after (b) 3 days, (c) 7 days, and (d) 14 days of immersion in artificial saliva. Smaller images show a magnified view of representative surface areas/deposits/precipitates seen in the background image. The tables next to the smaller images show the respective elemental compositions, expressed as wt% for all the elements and at% for those most relevant. In the right corner of every part of a figure is a magnification.

The SEM qualitative assessment of the surfaces of the SS brackets (Figures 1c,d, 2c,d and 3c,d) revealed numerous sub-micrometer-sized pits, larger irregularly shaped cavities, and large crystalline formations. EDX analysis of the unaffected areas (sp. 53, Figure 6a; sp. 12, Figure 6d) showed that the surface composition of those areas reflected the nominal alloy composition (Table 1). EDX spectra from the bottom of the large cavities (sp. 52, Figure 6a; sp. 26, Figure 6c) gave the equivalent result, which—together with visual assessment—indicated that those are not corrosion cavities, but most likely the consequence of polishing on that side of the bracket. The amounts of accompanying oxygen were such that the formation of protective oxide layer can be ruled out. After 3-day immersion, local hill-like deposits were observed (sp. 29, Figure 6b), but EDX spectra showed their

composition resembles that of the unaffected surface, indicating they were not corrosion products. The expected corrosion products for steel in a solution containing hydrogen carbonate and carbonate ions, in addition to iron oxides, are carbonate species such as siderite ( $\text{FeCO}_3$ ) and magnetite ( $\text{Fe}_3\text{O}_4$ ) [52,53], but we did not detect any of these species. Increased Al content was detected in some locations (sp. 23, Figure 6d). Large crystalline deposits, similarly to those observed on NiTi wires, contained equimolar amounts of K and Cl (Figure 6c), indicating KCl precipitation.

Some black pits contained large amounts of C (e.g., Spectrum 21, Figure 6b), indicating the formation of carbides [54]. However, in general, the EDX results of the areas encompassing black pits were not substantially different from those of the areas depleted from pits. Liu et al. [55] studied chemical composition around the pits on SS and found that the majority of pits have the identical composition to the bulk steel. Additionally, the corrosion resistance of the type of steel the brackets are made of (SS 1.4301, AISI 304) is classified as fair to good in various environments [56], but it is well known that pitting corrosion is most aggressive in solutions containing chloride ions, and frequently occurs in the oral cavity [54,57–61]. Hence, the observations made solely on the basis of the SEM micrographs, indicating the onset of pitting corrosion on the brackets even before the

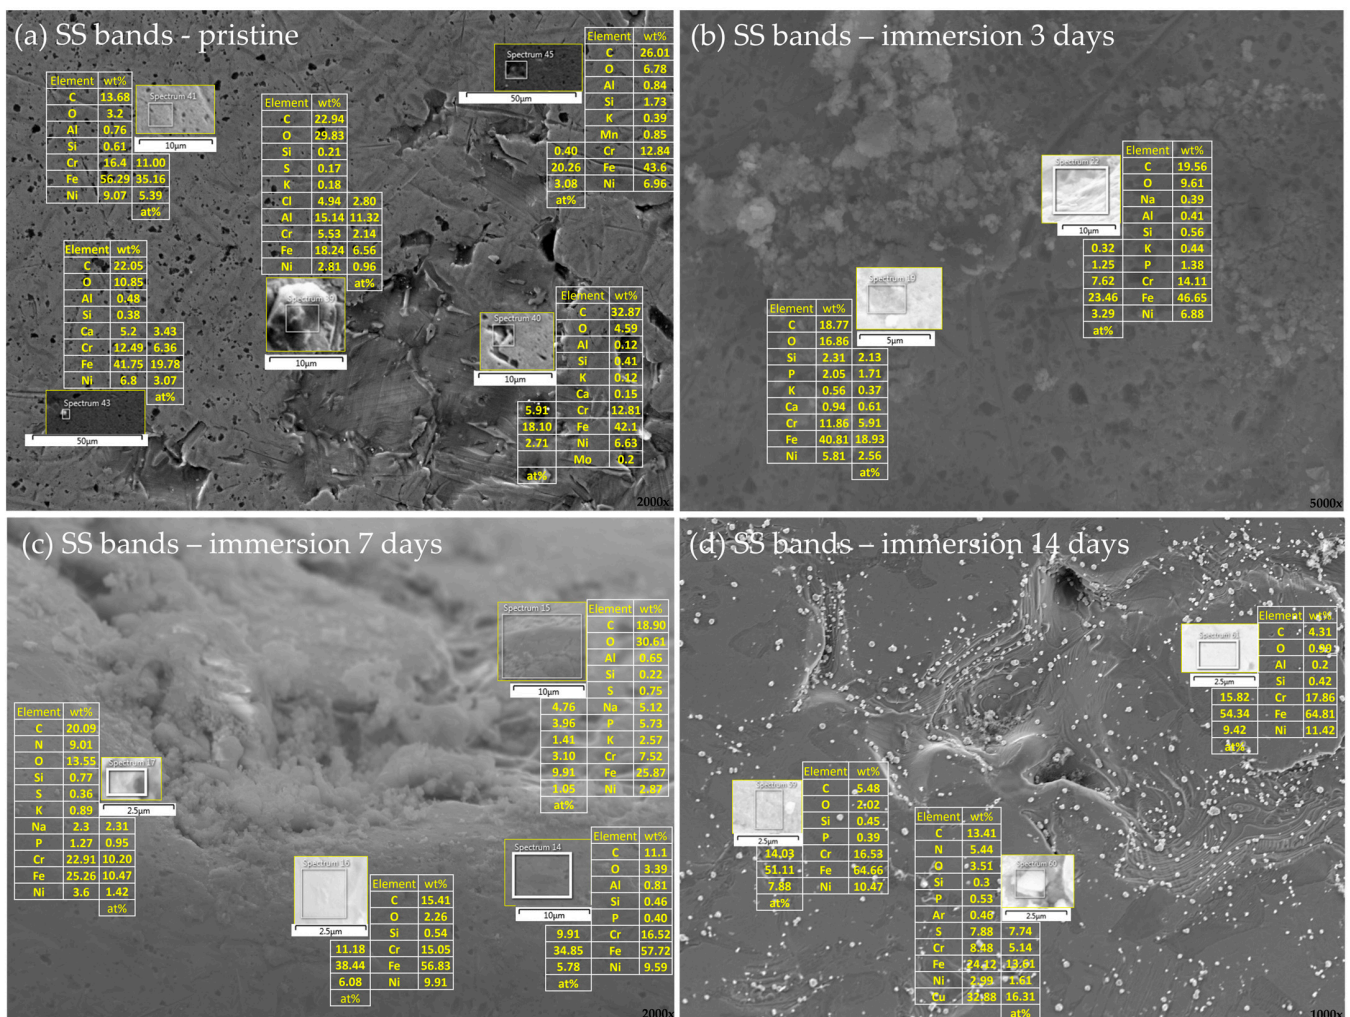
**Figure 7.** Elemental analysis of the band's surface in an (a) as-received state and after (b) 3 days, (c) 7 days, and (d) 14 days of immersion in artificial saliva. Smaller images show a magnified view of representative surface areas/deposits/precipitates seen in the background image. The tables next to the smaller images show the respective elemental compositions, expressed as wt% for all the elements and at% for those most relevant. In the right corner of every part of a figure is a magnification.

EDX analysis of the bands after immersion revealed higher amounts of oxygen compared to the brackets, indicating the formation of an oxide layer, which is consistent with the results of qualitative SEM analysis. The Al-rich deposits were also found (e.g., sp. 39, Figure 7a), but—contrarily to NiTi archwires and SS brackets—no KCl precipitates were observed. Small amounts of Ca-rich entities were found (e.g., sp. 43, Figure 7a), which might occur due to physical adsorption of calcium ions to the oxide layer [62]. An increased quantity of phosphorous atoms was observed, which could indicate the formation of phosphate deposits, which were not observed on archwires and brackets.

EDX analysis further disclosed the presence of metals not listed in the nominal composition of the bands, namely Cu (sp. 60, Figure 7d). A plausible explanation for the presence of copper might be found in the fact that Cu is a component of silver solder alloy, which is still the most commonly used soldering alloy in orthodontics [63,64]. Note that the SS bands are made of SS 1.4303 and SS 1.4551, with the latter being the filler metal. Copper(II) phosphate deposits were observed by Wendl et al. [8] on the bands with attachments from the same manufacturer.

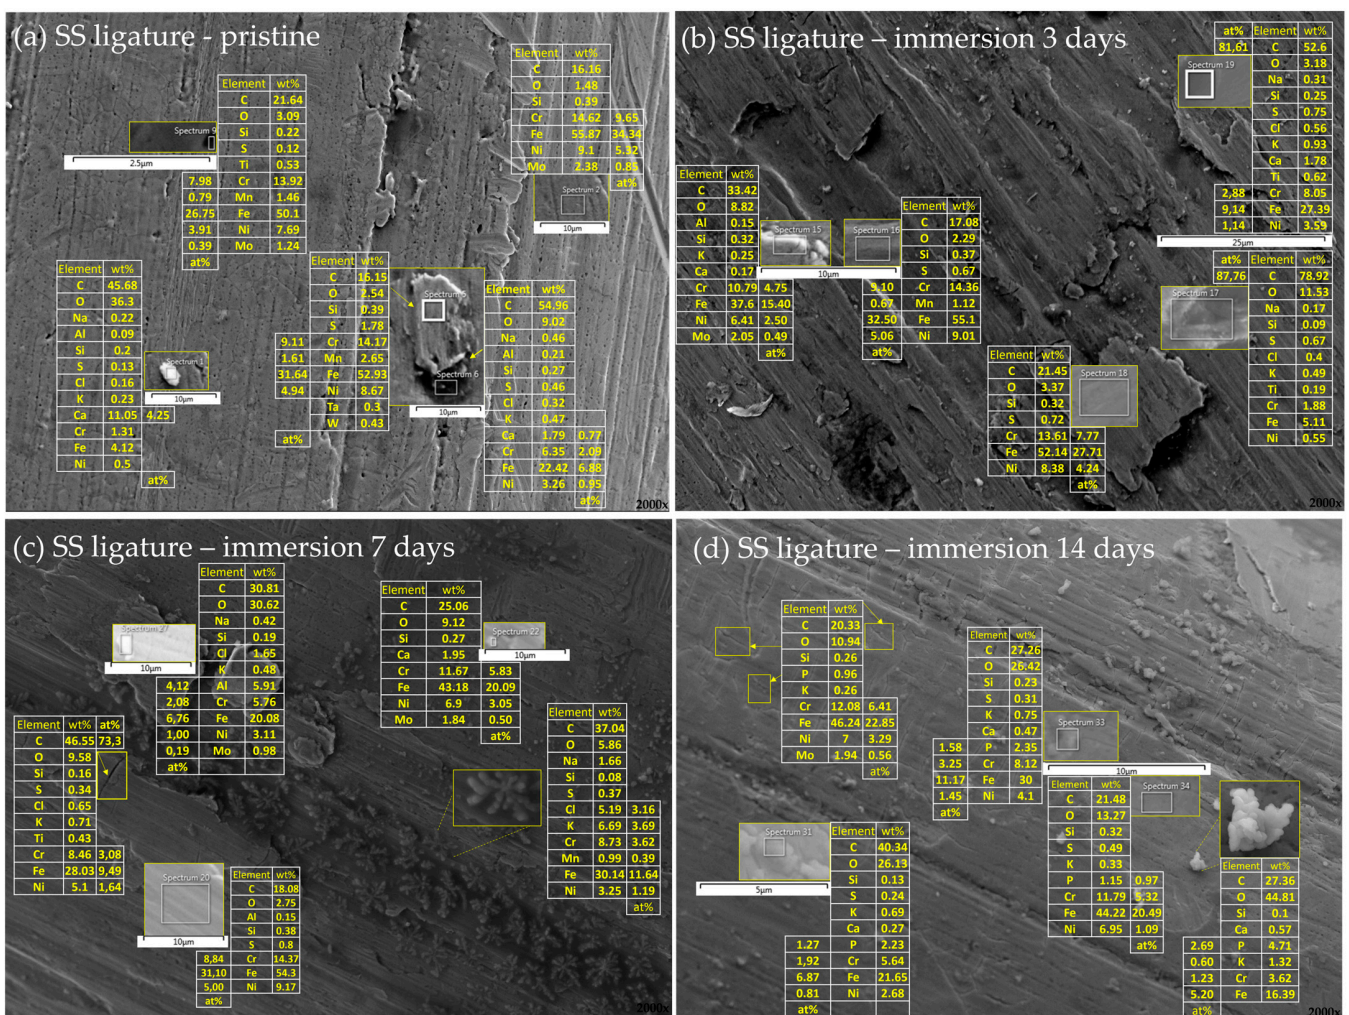
**Figure 8.** Elemental analysis of the ligatures surface in an (a) as-received state and after (b) 3 days, (c) 7 days, and (d) 14 days of immersion in artificial saliva. Smaller images show a magnified view of representative surface areas/deposits/precipitates seen in the background image. The tables next to the smaller images show the respective elemental compositions, expressed as wt% for all the elements and at% for those most relevant. In the right corner of every part of a figure is a magnification.

The elemental composition of the unaffected areas on the surface of the ligatures reflected the composition of the bulk. Ca-rich deposits were again observed, but were now accompanied by increased amounts of C and O, suggesting the formation of calcium carbonate. Compared to the brackets and bands, an increased number of sites containing extraordinary amounts of carbon were observed (sp. 17 and 19, Figure 8b; sp. 6, Figure 8a; etc.), but not in the form of pits as seen on the surface of the brackets (Figure 6b). Crystals with a peculiar morphology were observed in the striation after 7-day immersion (Figure 8c). Alongside the usual bulk elements, the EDX of these crystals showed equimolar amounts of K and Cl, indicating the formation of KCl crystals also on the surface of the ligatures, but—in contrast to KCl-rich deposits on archwires and bands—their morphology on the ligatures was markedly different. A multitude of crystal morphologies has been found for salivary crystals [37], including rectangular, polyhedral, ovoid, and rod-like, with the latter describing well the morphology seen on Figure 8c.

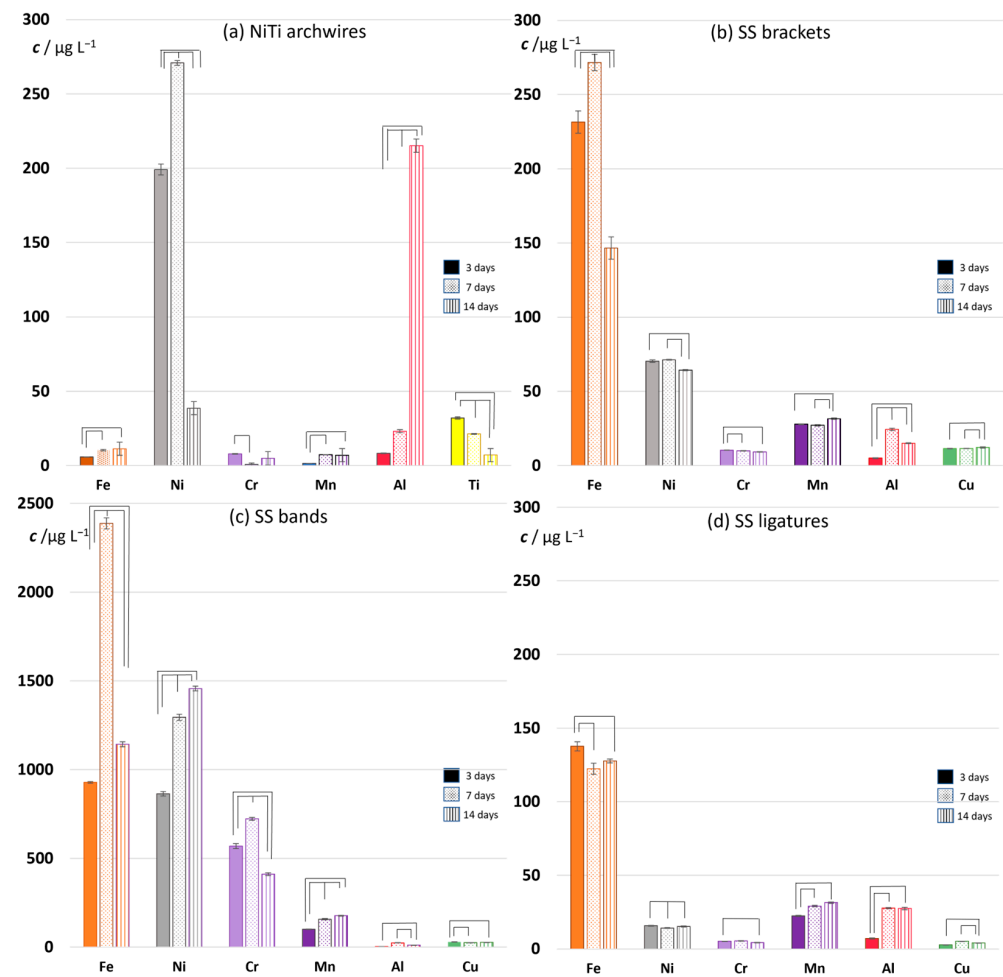
**Figure 9.** The concentrations of the most relevant ions released from (a) NiTi archwires, (b) SS brackets, (c) SS bands, and (d) SS ligatures after 3-, 7-, and 14-day immersion in artificial saliva at 37 °C. The lines/connections associate the metal ion concentrations that differ significantly (ANOVA, Post hoc Tukey HSD test,  $p < 0.05$ ).

The results of metal ion release from NiTi archwires immersed in artificial saliva for 3, 7 and 14 days are shown in Figure 9a. After 3 days, the relative order of eluted concentrations

of the three most abundant elements in the nominal composition was preserved ( $\text{Ni} > \text{Ti} > \text{Fe}$ ), but the relative amounts were not proportional; as expected, the concentration of Ni far exceeded its nominal weight percentage compared to the other ions, similar to findings of Papaionau [20]. Notably, the concentrations of Al, Cr, Zn, Sr, and Rb all exceeded the Fe concentration, even though they were not listed in the nominal composition. EDX analysis indicated the presence of aluminum oxide on the surface of the archwire (Section 3.2.1), which explains the relatively high eluted Al concentration. However, the other elements were not detected at any of the analyzed sites. The non-negligible eluted concentrations of Mn, Cu, Mo, Ba, and Pb ions were also measured (Supplementary Materials Table S1).

From day 3 to day 7, the concentrations of all the elements increased, except those of Ti and Cr. By day 7, the Ti and Cr concentrations decreased by one-third and by an order of magnitude, respectively. With further immersion, a seemingly erratic trend in concentration change could be observed, and the trends differed for each element. This kind of erratic behavior has been reported in other studies [61]. The concentrations of some elements reached a maximum on day 7, most notably Ni. A pronounced maximum observed for Ni after 7-day immersion is consistent with previous studies [65,66], although divergent results have also been reported [8]. While Ni concentration drastically decreased by day 14, Al concentration markedly increased. The increase throughout the whole measurement

For all SS appliances (Figure 9b–d), Fe was the most abundant of the eluted ions, as expected. After 3 days of immersion, the relative order of eluted concentrations of the four most abundant elements in the nominal composition ( $\text{Fe} > \text{Cr} > \text{Ni} > \text{Mn}$ ) was not maintained, nor were their relative amounts. Namely, Ni was detected in higher concentrations than Cr, consistent with the literature [20,67]. While an increase in eluted concentrations of all the elements apart from Ti and Cr were observed for NiTi wires from day 3 to day 7, a corresponding trend was observed only for the bands among the SS parts of the appliance. For most elements eluted from the brackets and ligatures, the values stagnated or slightly decreased during the same period. For ligatures, even the Fe concentration was lower after 7-day immersion. The trends of Ni were different for the individual parts of the appliance: a significant increase throughout the measurement period for the bands, stagnation for the ligatures, and a slight decrease on day 14 for the brackets.

Figure 9 showed the eluted concentrations of the most relevant ions, not the most abundant ones. Data for all the eluted ions for each part of appliance are given in Supplementary Materials Table S1. High concentrations of certain ions can be observed, namely, calcium, rubidium, and zinc. These ions originate from the artificial saliva itself, as shown in Figure 10a, and were therefore excluded from data shown in Figure 9.

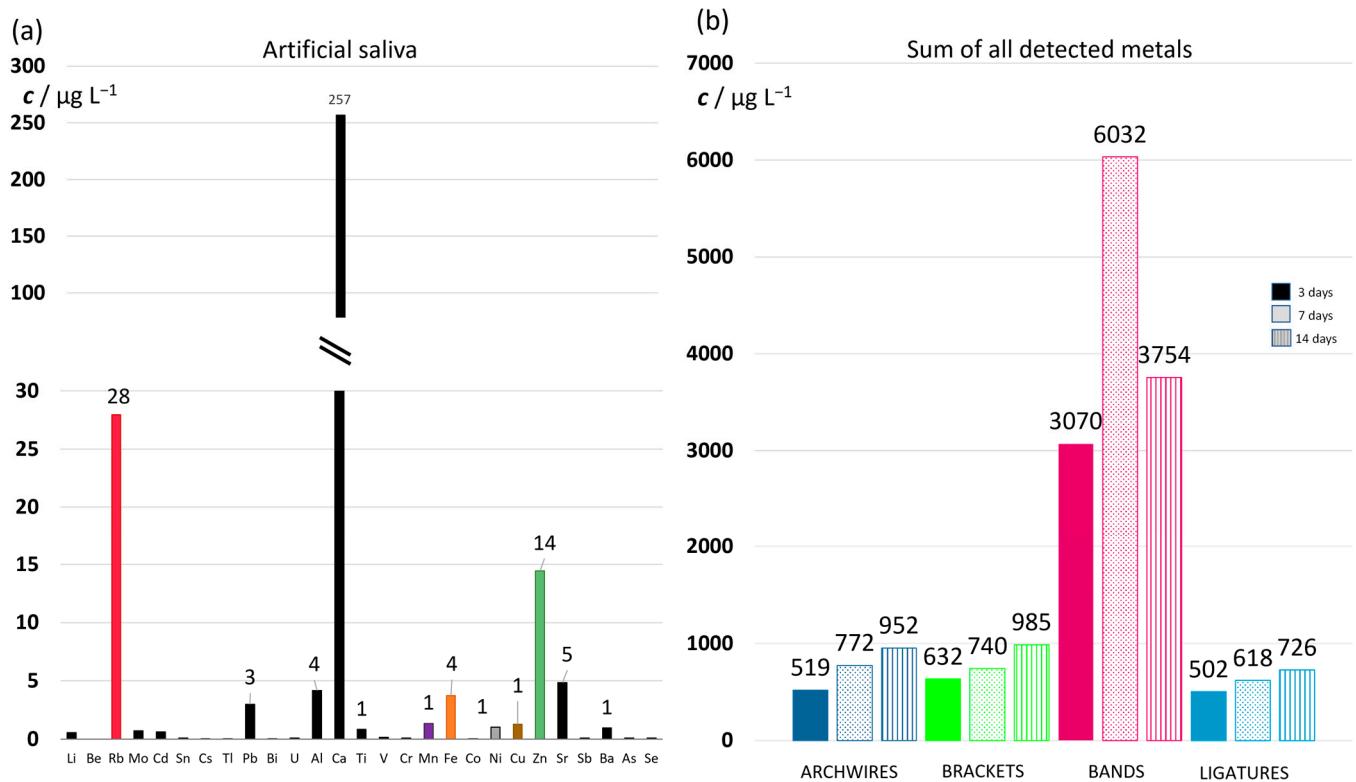
**Figure 10.** (a) The concentrations of the most abundant ions found in artificial saliva; (b) the sum of concentrations of all detected metals in archwires, brackets, bands, and ligatures after 3-, 7-, and 14-day immersion in artificial saliva at 37 °C.

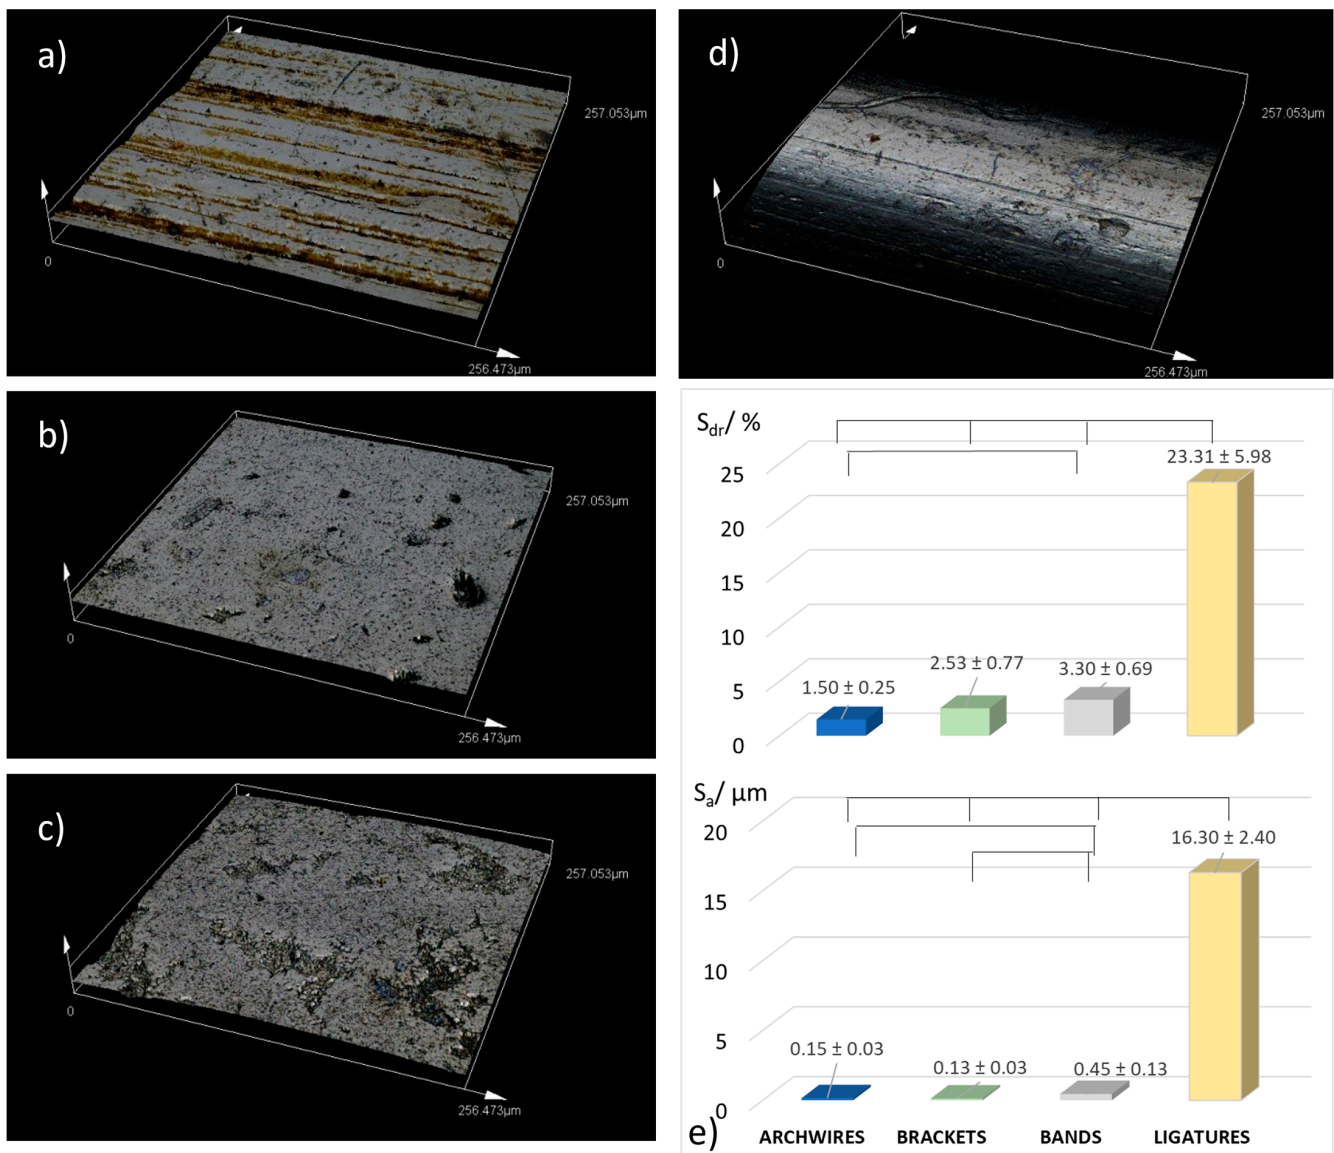
**Figure 11.** Representative CLMX images of (a) NiTi archwires, (b) SS brackets, (c) SS bands, and (d) SS ligatures, after 7-day immersion in artificial saliva. Surface roughness (e) is given as arithmetic mean surface roughness,  $S_a$ , and the developed interfacial area ratio,  $S_{dr}$ . The lines/connections associate the surface roughness values that differ significantly (Mann–Whitney U test,  $p < 0.05$ ).

The  $S_{dr}$  parameter revealed that the surface roughness is significantly higher for the ligatures compared to all other appliances. The ordering based on surface roughness showed no correlation with the eluted ion concentrations (Figure 10b). The ligatures, with the highest surface roughness, released on average the lowest amounts of ions. The bands, which released excessively high amounts of ions, had roughness similar to that of wires and brackets, and significantly lower roughness than ligatures. Such results imply that, in

accordance with the majority of literature data, for our samples the surface roughness was not correlated to the amount of released ions.
