Cytotoxicity of Metal Ions Released from NiTi and Stainless Steel Orthodontic Appliances, Part 1: Surface Morphology and Ion Release Variations

Source / Izvornik: **Materials**, 2023, 16

Abstract: Despite numerous studies on ion release from orthodontic appliances, no clear conclusions can be drawn due to complex interrelations of multiple factors. Therefore, as the first part of a comprehensive investigation of cytotoxicity of eluted ions, the objective of this study was to analyze four parts of a fixed orthodontic appliance. Specifically, NiTi archwires and stainless steel (SS) brackets, bands, and ligatures were immersed in artificial saliva and studied for morphological and chemical changes after 3-, 7-, and 14-day immersion, using the SEM/EDX technique. Ion release profiles were analyzed for all eluted ions using inductively coupled plasma mass spectrometry (ICP-MS). The results demonstrated dissimilar surface morphologies among parts of the fixed appliance, due to variations in manufacturing processes. The onset of pitting corrosion was observed for the SS brackets and bands in the as-received state. Protective oxide layers were not observed on any of the parts, but adheren

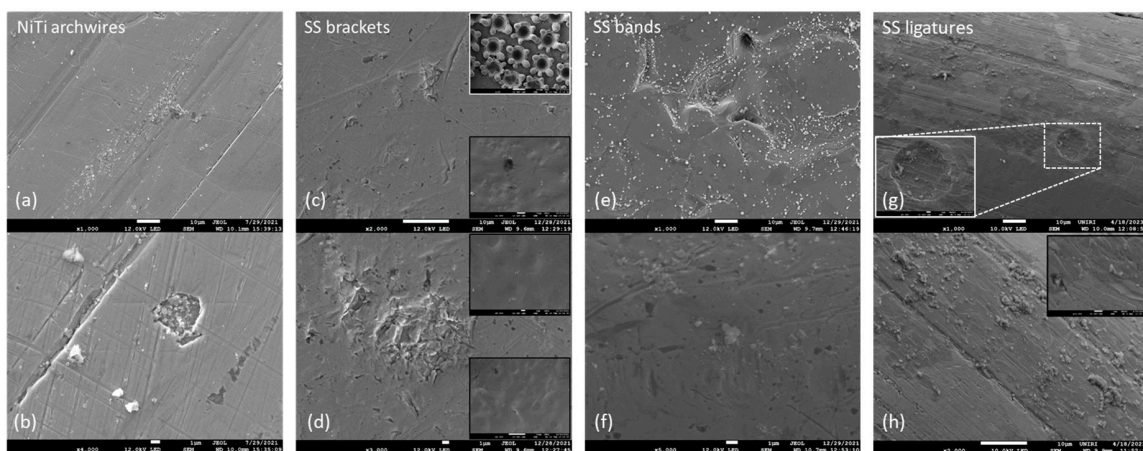
Figure 4. Representative lower magnification (top row) and higher magnification (bottom row) SEM micrographs of (a,b) NiTi archwires, (c,d) stainless steel (SS) brackets, (e,f) SS bands, and (g,h) SS ligatures, after 14-day immersion in artificial saliva.

After 14-day immersion, development was observed on the surface of the NiTi archwires (Figure 4a,b). New crevices and grooves were formed, and the surface—both on the inside and the outside of the surface irregularities—was abundant with white precipitates/deposits of various sizes. No signs of pitting corrosion were observed.

Pitting corrosion appeared to be slightly advanced on the SS bracket surface (Figure 4c,d), but this should be confirmed by quantitative methods. For comparison, Frois et al. [31] found no relevant morphological changes on the surface even after 30 days of immersion. New deposits of specific morphology formed, having a size of a few tens of micrometers. Larger white crystal deposits were rare and located on the underside of the bracket (addendums Figure 4c,d). Deposits also occurred on flower-like structures (upper addendum on Figure 4c).

Results for the SS bands showed a drastic increase in the number of white precipitates (Figure 4e). The protective layer (Figure 4f) appeared similar to that observed after 7-day immersion (Figure 3f).

The surface of the ligatures changed: irregular patches were observed, indicating the formation of the protective layer (Figure 4g,h). Large amounts of debris and precipitates were present, and located on the top of the protective layer, not on the unaffected areas.

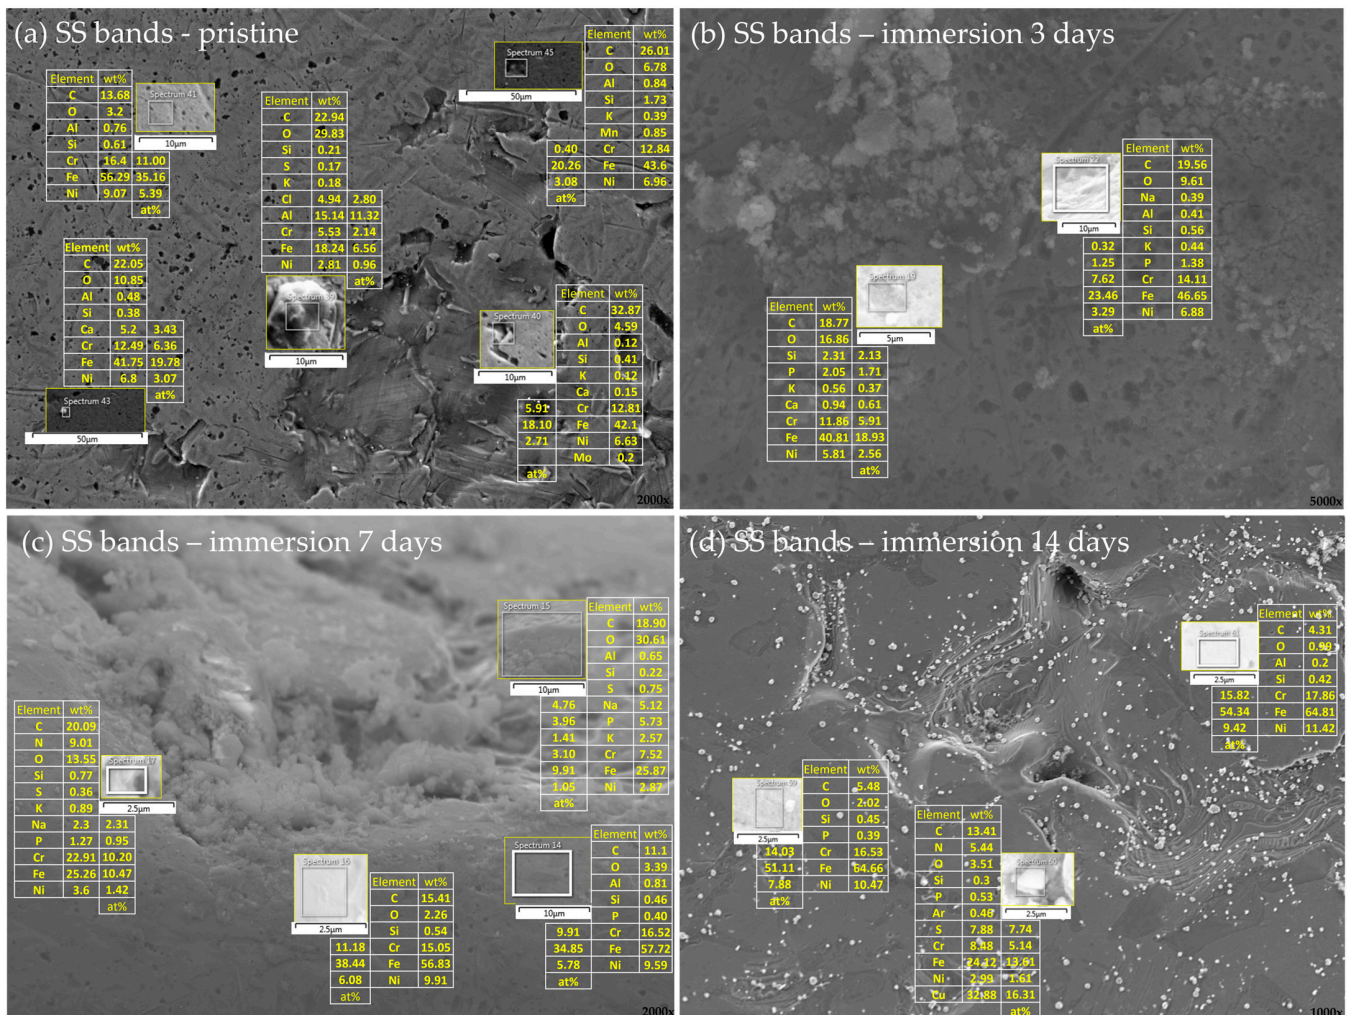
Figure 7. Elemental analysis of the band's surface in an (a) as-received state and after (b) 3 days, (c) 7 days, and (d) 14 days of immersion in artificial saliva. Smaller images show a magnified view of representative surface areas/deposits/precipitates seen in the background image. The tables next to the smaller images show the respective elemental compositions, expressed as wt% for all the elements and at% for those most relevant. In the right corner of every part of a figure is a magnification.

immersion in AS, cannot be rejected. Similar results were obtained for the SS bands in the pristine state (Figure 7a).

EDX analysis of the bands after immersion revealed higher amounts of oxygen compared to the brackets, indicating the formation of an oxide layer, which is consistent with the results of qualitative SEM analysis. The Al-rich deposits were also found (e.g., sp. 39, Figure 7a), but—contrarily to NiTi archwires and SS brackets—no KCl precipitates were observed. Small amounts of Ca-rich entities were found (e.g., sp. 43, Figure 7a), which might occur due to physical adsorption of calcium ions to the oxide layer [62]. An increased quantity of phosphorous atoms was observed, which could indicate the formation of phosphate deposits, which were not observed on archwires and brackets.

EDX analysis further disclosed the presence of metals not listed in the nominal composition of the bands, namely Cu (sp. 60, Figure 7d). A plausible explanation for the presence of copper might be found in the fact that Cu is a component of silver solder alloy, which is still the most commonly used soldering alloy in orthodontics [63,64]. Note that the SS bands are made of SS 1.4303 and SS 1.4551, with the latter being the filler metal. Copper(II) phosphate deposits were observed by Wendl et al. [8] on the bands with attachments from the same manufacturer.
