Source / Izvornik: **Materials, 2023, 16**

Cytotoxicity of Metal Ions Released from NiTi and Stainless Steel Orthodontic Appliances, Part 1: Surface Morphology and Ion Release Variations

Keywords: orthodontic appliances; ion elution; surface properties; NiTi; stainless steel; ligatures; brackets; bands

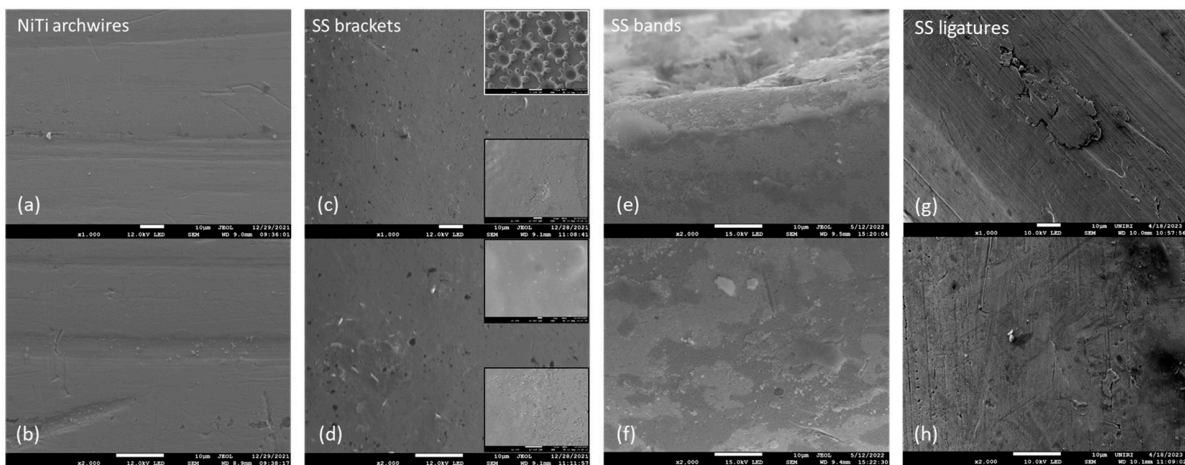
Figure 2. Representative lower magnification (top row) and higher magnification (bottom row) SEM micrographs of (a,b) NiTi archwires, (c,d) stainless steel brackets (SS), (e,f) SS bands, and (g,h) SS ligatures, after 3 days of immersion in artificial saliva.

Three days of immersion did not notably enhance the pitting corrosion in SS brackets, nor did it result in deposits or adherent material. However, the protrusion of crystal clusters from the bulk was observed. Higher magnification images (representative image given as upper addendum in Figure 2d) further indicated that the small white entities were not the adhering material. Besides those, the lower bracket surface, containing areas of various morphologies (addendums in Figure 2c,d), also showed no notable changes.

On the contrary, the SEM micrographs of SS bands (Figure 2e,f) showed prominent changes and a very small portion of the unaffected surface. Most of the surface was covered with an adherent layer that was not detected on other parts of the fixed appliance. This layer can be recognized as an oxide protective layer, which is common on SS products [30–33]. Lighter colored deposits were observed on the top of the protective layer and in the areas in between, which were reminiscent of layer debris [34].

Black pits were visible on the surface of SS ligatures (Figure 2g,h), indicating the onset of corrosion. An increased number of white crystal precipitates was also observed.

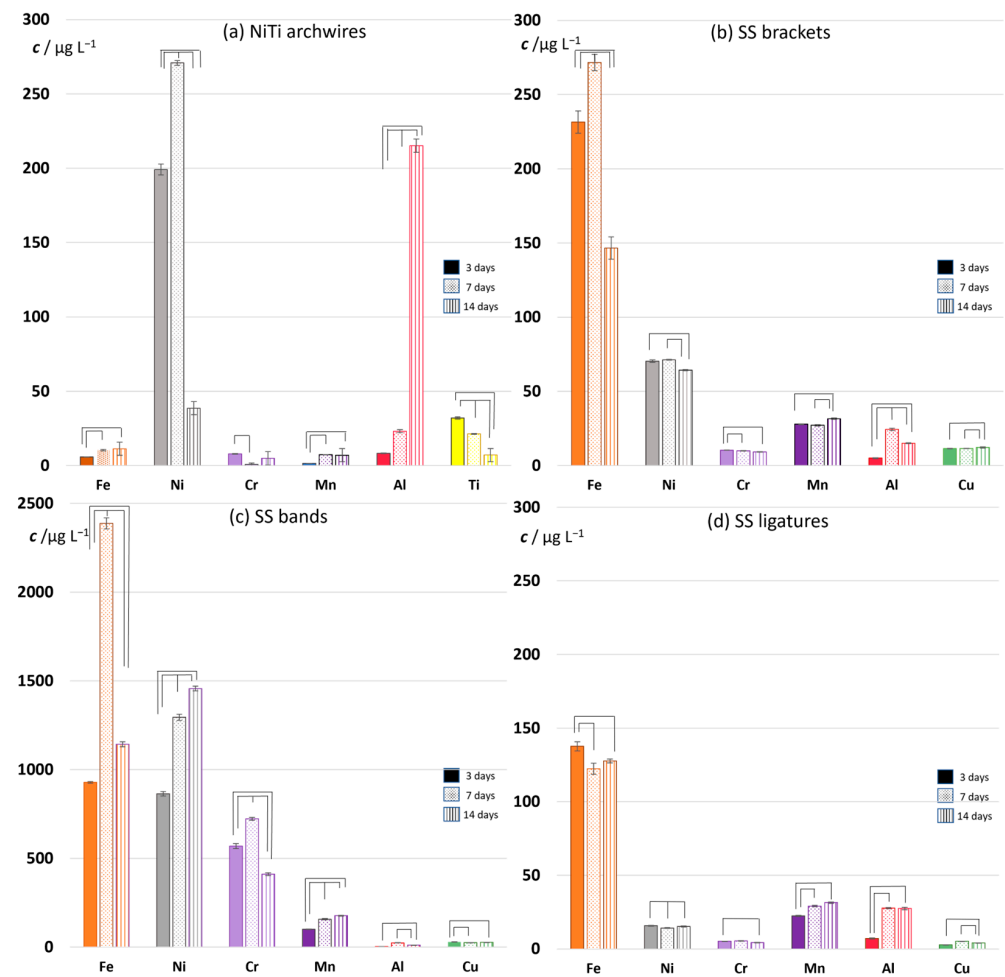
Figure 9. The concentrations of the most relevant ions released from (a) NiTi archwires, (b) SS brackets, (c) SS bands, and (d) SS ligatures after 3-, 7-, and 14-day immersion in artificial saliva at 37 °C. The lines/connections associate the metal ion concentrations that differ significantly (ANOVA, Post hoc Tukey HSD test, $p < 0.05$).

The results of metal ion release from NiTi archwires immersed in artificial saliva for 3, 7 and 14 days are shown in Figure 9a. After 3 days, the relative order of eluted concentrations

of the three most abundant elements in the nominal composition was preserved ($\text{Ni} > \text{Ti} > \text{Fe}$), but the relative amounts were not proportional; as expected, the concentration of Ni far exceeded its nominal weight percentage compared to the other ions, similar to findings of Papaionau [20]. Notably, the concentrations of Al, Cr, Zn, Sr, and Rb all exceeded the Fe concentration, even though they were not listed in the nominal composition. EDX analysis indicated the presence of aluminum oxide on the surface of the archwire (Section 3.2.1), which explains the relatively high eluted Al concentration. However, the other elements were not detected at any of the analyzed sites. The non-negligible eluted concentrations of Mn, Cu, Mo, Ba, and Pb ions were also measured (Supplementary Materials Table S1).

From day 3 to day 7, the concentrations of all the elements increased, except those of Ti and Cr. By day 7, the Ti and Cr concentrations decreased by one-third and by an order of magnitude, respectively. With further immersion, a seemingly erratic trend in concentration change could be observed, and the trends differed for each element. This kind of erratic behavior has been reported in other studies [61]. The concentrations of some elements reached a maximum on day 7, most notably Ni. A pronounced maximum observed for Ni after 7-day immersion is consistent with previous studies [65,66], although divergent results have also been reported [8]. While Ni concentration drastically decreased by day 14, Al concentration markedly increased. The increase throughout the whole measurement

For all SS appliances (Figure 9b–d), Fe was the most abundant of the eluted ions, as expected. After 3 days of immersion, the relative order of eluted concentrations of the four most abundant elements in the nominal composition ($\text{Fe} > \text{Cr} > \text{Ni} > \text{Mn}$) was not maintained, nor were their relative amounts. Namely, Ni was detected in higher concentrations than Cr, consistent with the literature [20,67]. While an increase in eluted concentrations of all the elements apart from Ti and Cr were observed for NiTi wires from day 3 to day 7, a corresponding trend was observed only for the bands among the SS parts of the appliance. For most elements eluted from the brackets and ligatures, the values stagnated or slightly decreased during the same period. For ligatures, even the Fe concentration was lower after 7-day immersion. The trends of Ni were different for the individual parts of the appliance: a significant increase throughout the measurement period for the bands, stagnation for the ligatures, and a slight decrease on day 14 for the brackets.

Figure 9 showed the eluted concentrations of the most relevant ions, not the most abundant ones. Data for all the eluted ions for each part of appliance are given in Supplementary Materials Table S1. High concentrations of certain ions can be observed, namely, calcium, rubidium, and zinc. These ions originate from the artificial saliva itself, as shown in Figure 10a, and were therefore excluded from data shown in Figure 9.

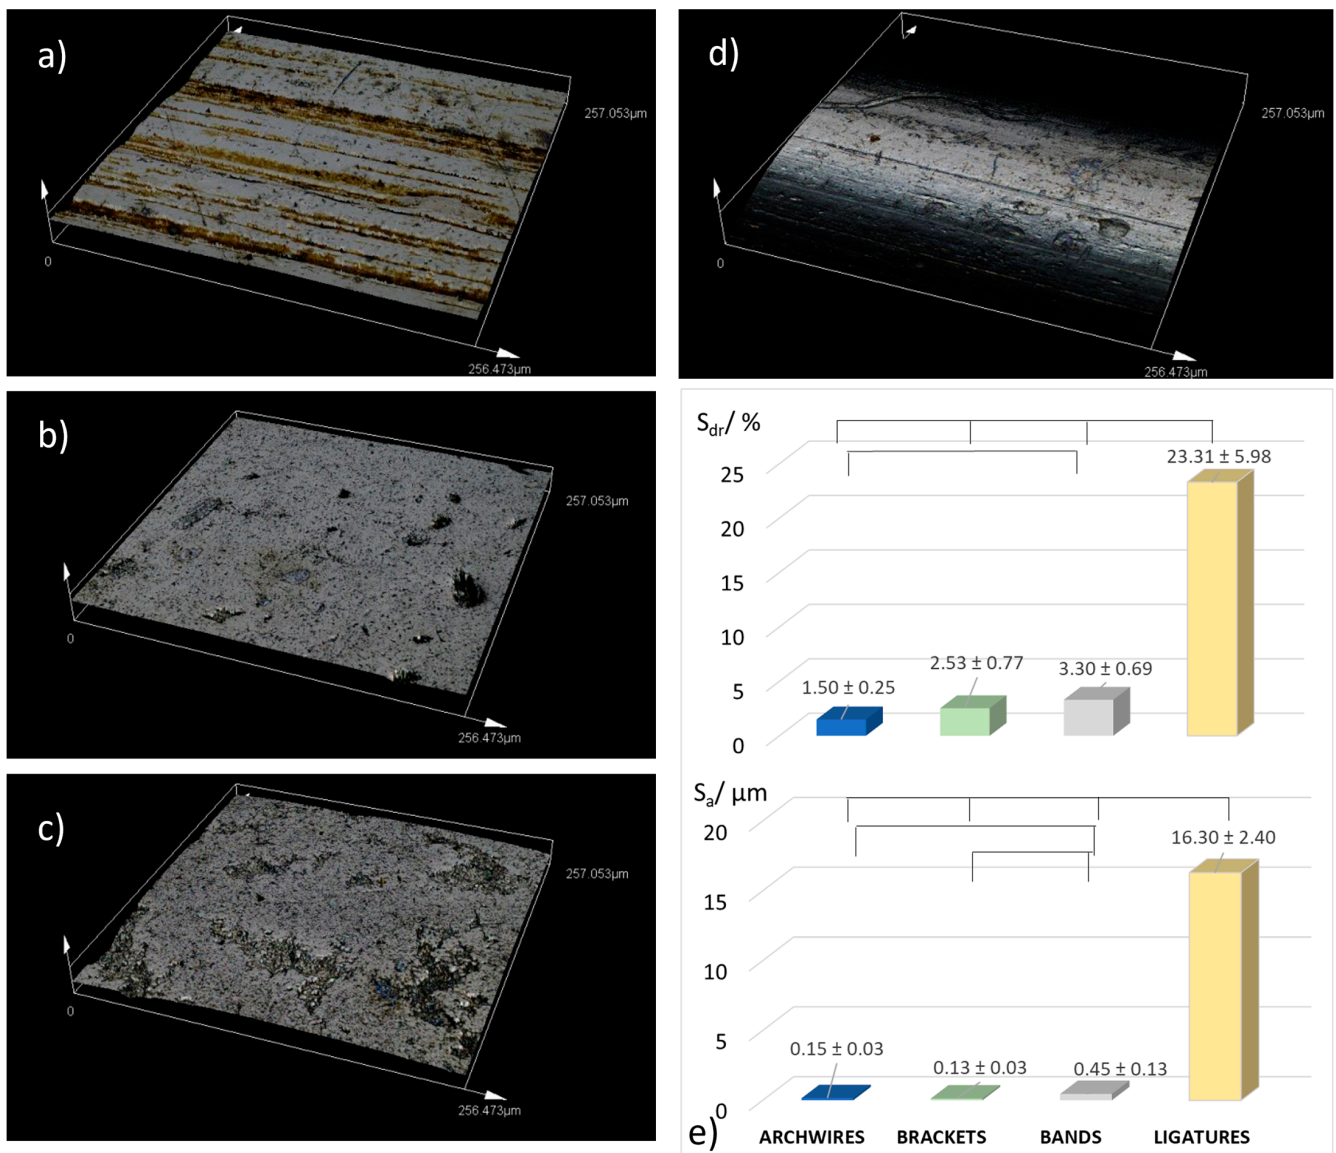
Figure 11. Representative CLMX images of (a) NiTi archwires, (b) SS brackets, (c) SS bands, and (d) SS ligatures, after 7-day immersion in artificial saliva. Surface roughness (e) is given as arithmetic mean surface roughness, S_a , and the developed interfacial area ratio, S_{dr} . The lines/connections associate the surface roughness values that differ significantly (Mann–Whitney U test, $p < 0.05$).

The S_{dr} parameter revealed that the surface roughness is significantly higher for the ligatures compared to all other appliances. The ordering based on surface roughness showed no correlation with the eluted ion concentrations (Figure 10b). The ligatures, with the highest surface roughness, released on average the lowest amounts of ions. The bands, which released excessively high amounts of ions, had roughness similar to that of wires and brackets, and significantly lower roughness than ligatures. Such results imply that, in

accordance with the majority of literature data, for our samples the surface roughness was not correlated to the amount of released ions.
