Cytotoxicity of Metal Ions Released from NiTi and Stainless Steel Orthodontic Appliances, Part 1: Surface Morphology and Ion Release Variations

Journal article, Published version

Article

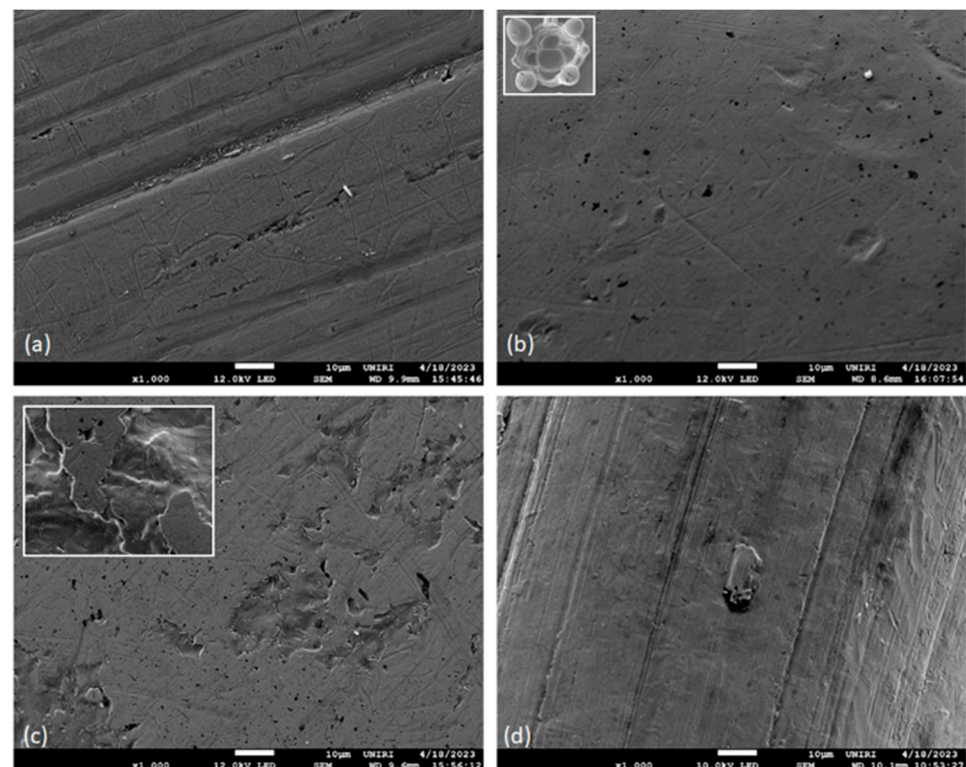
Figure 1. Representative SEM micrographs of (a) NiTi archwires, (b) stainless steel (SS) brackets, (c) SS bands and (d) SS ligatures, before immersion in artificial saliva.

The surface of the brackets and the bands (Figure 1b,c) contained other types of heterogeneities, most notably the black spots/pits ranging from submicron to several microns in size. The spots resembled corrosion cavities, thus indicating that the corrosion process has started before the immersion in artificial saliva. The onset of pitting corrosion on new orthodontic appliances has been reported in other studies as well [9,25]. On the other hand, no corrosion pits were noticed on the NiTi wires and ligatures, even though the ligatures were made of a very similar type of SS as the brackets (Table 1). Data obtained from the manufacturer confirmed that no coatings or additives were used on the ligatures (private correspondence); hence, the differences probably arose from variations in the manufacturing process. Indeed, it has been demonstrated that the polishing of NiTi wires to a uniform finish reduces the corrosion rate [9,26].

Alongside the corrosion pits, the brackets contained very few other morphological features, except numerous flower-like formations on the underside (depicted in the addendum in Figure 1b), arranged in a formation that reflected one of the possible shapes of the base morphology [27], with a purpose of improving the adhesion to the tooth [28]. The bands (Figure 1c) contained large, irregularly shaped cavities several tens of micrometers in size, with smooth areas in between. The lower side (the addendum in Figure 1c) contained a markedly smaller proportion of smooth areas. The differences between the two sides, also visible macroscopically, are the result of intentionally lower polishing level of the lower side, again to improve the adhesion to the tooth.

The SEM micrographs also showed that all parts except the ligatures contained small amounts of approximately micrometer-sized white crystal deposits. Similar impurities were found in other studies, located in the corrosion pits [25] or elsewhere on the surface [29].

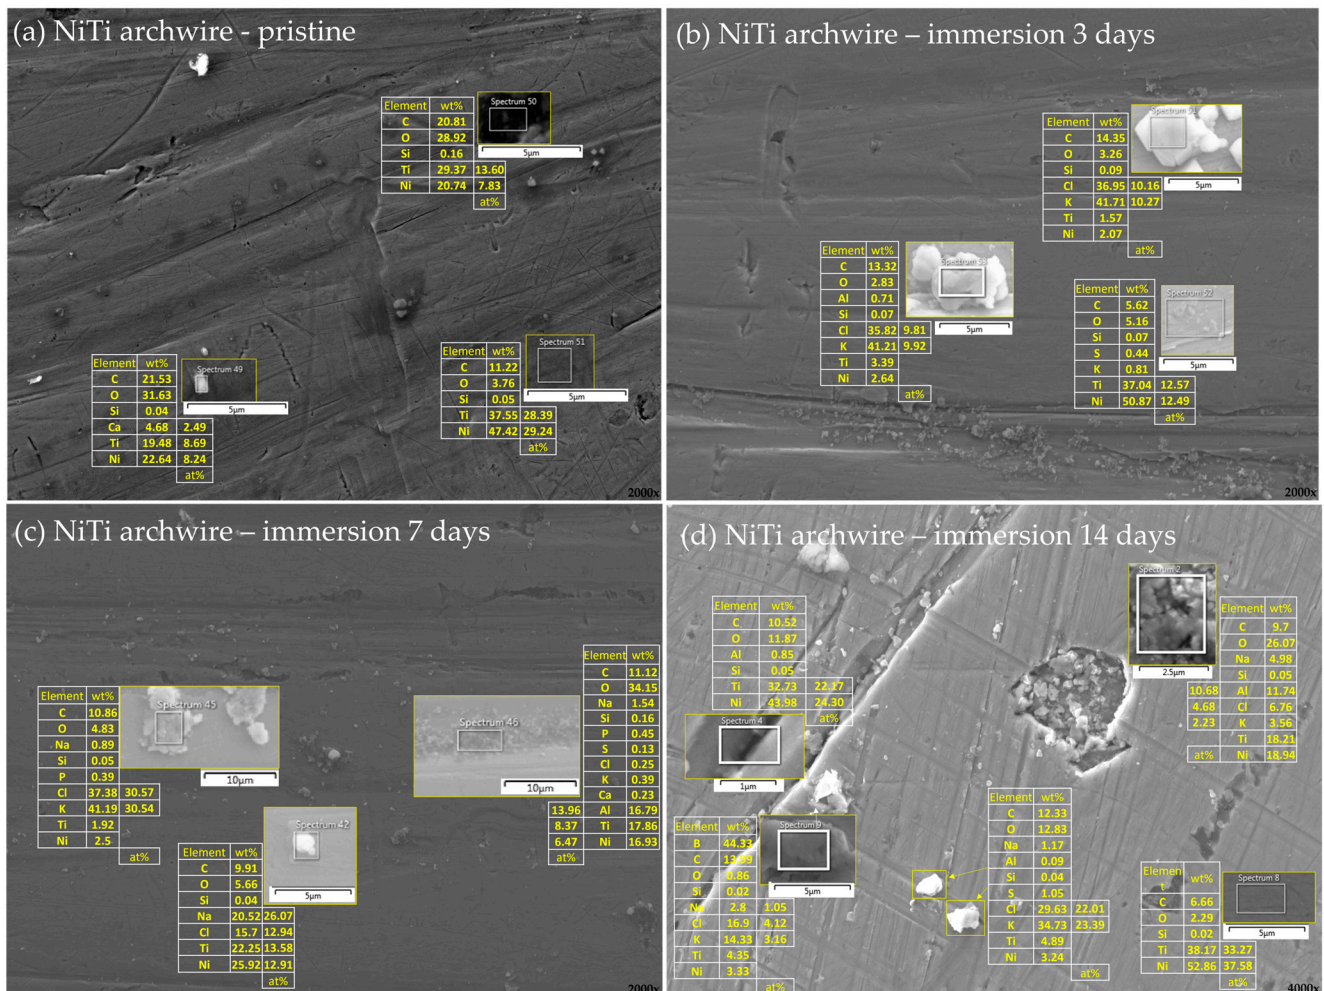
Figure 5. Elemental analysis of the archwire surface in an (a) as-received state and after (b) 3 days, (c) 7 days, and (d) 14 days of immersion in artificial saliva. Smaller images show a magnified view of representative surface areas/deposits/precipitates seen in the background image. The tables next to the smaller images show the respective elemental compositions, expressed as wt% for all the elements and at% for those most relevant. In the right corner of every part of a figure is a magnification.

Representative results for the surface of the NiTi archwire are shown in Figure 5. The elemental composition of the smooth unaffected regions (e.g., Spectrum 51, Figure 5a; Spectrum 52, Figure 5b; Spectrum 8, Figure 5d) showed that the ratio of Ni and Ti atomic percentages in these regions was approximately 1:1, indicating that in those areas the surface composition reflects the nominal composition of the alloy (Table 1). Moreover, comparing the relative amounts of Ni and Ti with oxygen for those locations, a very low oxygen level can be observed. Correlating this result with, for example, those reported in a study by Carroll and Kelly [5], it can be inferred that the typical oxide layer [23,24,29,38–41] did not form. This is also in accordance with the SEM results, where the protective layer would be visible due to its specific texture [24]. Note that the results showed that the oxide layer did not form even after 14-day immersion (sp. 8, Figure 5d). As indicated by SEM and confirmed by EDX, the NiTi wires used in this study were obviously depleted of the protective oxide layer, which is done by mechanical polishing [5]. Devices with a mechanically and electrolytically polished NiTi surface are also used as implants [29]. The studies showed that the prevention of Ni release by a thick oxide layer can be inadequate because it led to Ni accumulation below the protective layer, which served as a reservoir for Ni release in the case of surface damage, and led to the onset of pitting corrosion [29,42]. It has been shown that polished NiTi surfaces exhibited improved resistance to localized corrosion attacks in a chloride-rich medium [6].

On some locations, the 2:1 atomic ratio of Ti and Ni was found (sp. 50, Figure 5b). This result implied the formation of Ti_2Ni phase, which typically occurs in NiTi wires [19,38,43,44]. Increased carbon content was observed in some locations, which could theoretically indicate the formation of the titanium carbide [38,41,45,46], but it is less likely due to the above-given reasons regarding carbon measurements with EDX. The dark grains of pure Ti, observed in some studies [6], were not found in our samples.

EDX analysis also revealed that the large crystallites observed on the NiTi surface consisted of equimolar amounts of K and Cl (sp. 51 and 53, Figure 5b; sp. 45, Figure 5c and yellow squared parts, Figure 5d), indicating the precipitation of potassium chloride crystals. In some cases (sp. 9, Figure 5d), the results implied that part of the K^+ ions was exchanged with Na^+ . Potassium chloride is a highly soluble salt (~39 g per 100 g H_2O at 37 °C) and was observed only on samples after immersion; hence, it can be inferred that the crystals formed after the evaporation of artificial saliva. Eliades et al. [47] reported the formation of microcrystalline KCl and NaCl deposits as well, on the surface of NiTi wires taken after 1–6 months in vivo, which substantially altered the surface composition and topography. Note that the artificial saliva used in our study contained potassium chloride and other potassium and sodium salts (vide supra, Section 2.2).

The crystals on the as-received NiTi samples contained elevated amounts of calcium ions (sp. 49, Figure 5a), accompanied by relatively high amounts of C and O, which might suggest the formation of calcium carbonate. Alongside large white precipitates, other types of deposits could be distinguished. The EDX analysis of smaller gray entities (<0.5 μm), distributed over wide areas as clusters or individually, showed equimolar amounts of Ni and Ti (sp. 52, Figure 5b) with low oxygen content, confirming them as manufacturing debris. Calcium phosphate deposits, found in previous studies after NiTi immersion in phosphate-containing solutions [6,23,48], were not detected on our samples.

Elemental analysis also showed that some of the small crystal clusters contained appreciable amounts of aluminum (e.g., Spectrum 46, Figure 5b; Spectrum 2, Figure 5c), accompanied by an increased amount of oxygen, indicating a possible formation of aluminum oxide (alumina). This result is noteworthy because aluminum was not listed in the nominal alloy composition. Yet, in several studies, some amounts of Al were found on the surface of the as-received samples [41], among the released ions in the artificial saliva and in the artificial saliva itself [49], and in the surface precipitates [25]. Moreover, Gravina et al. studied the composition of NiTi wires from six different companies and found Al_2O_3 in all

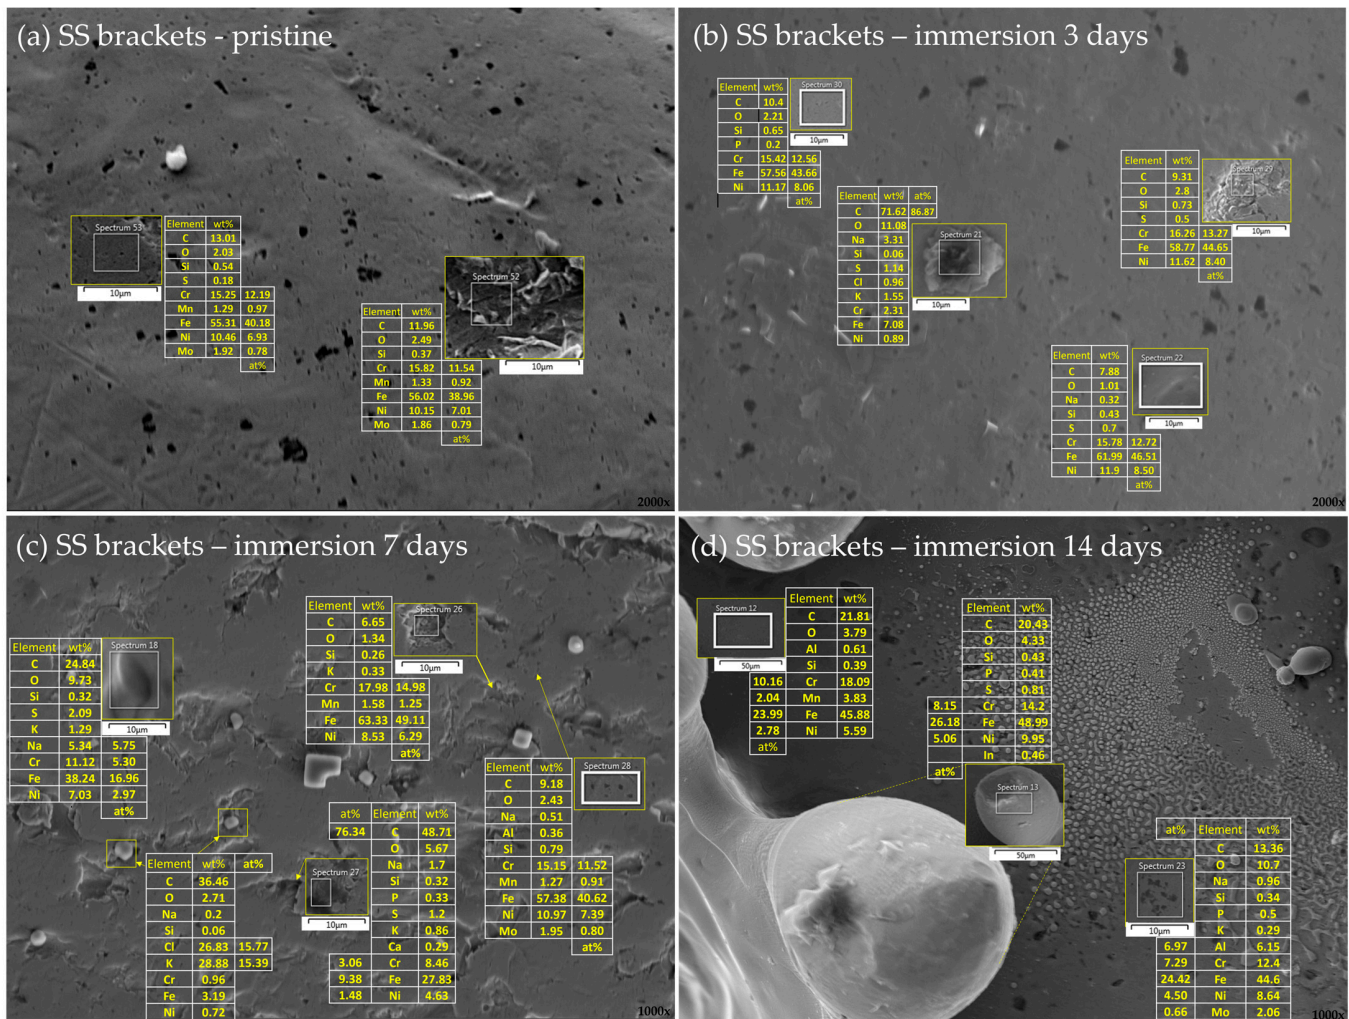
Figure 6. Elemental analysis of the bracket's surface in an (a) as-received state and after (b) 3 days, (c) 7 days, and (d) 14 days of immersion in artificial saliva. Smaller images show a magnified view of representative surface areas/deposits/precipitates seen in the background image. The tables next to the smaller images show the respective elemental compositions, expressed as wt% for all the elements and at% for those most relevant. In the right corner of every part of a figure is a magnification.

The SEM qualitative assessment of the surfaces of the SS brackets (Figures 1c,d, 2c,d and 3c,d) revealed numerous sub-micrometer-sized pits, larger irregularly shaped cavities, and large crystalline formations. EDX analysis of the unaffected areas (sp. 53, Figure 6a; sp. 12, Figure 6d) showed that the surface composition of those areas reflected the nominal alloy composition (Table 1). EDX spectra from the bottom of the large cavities (sp. 52, Figure 6a; sp. 26, Figure 6c) gave the equivalent result, which—together with visual assessment—indicated that those are not corrosion cavities, but most likely the consequence of polishing on that side of the bracket. The amounts of accompanying oxygen were such that the formation of protective oxide layer can be ruled out. After 3-day immersion, local hill-like deposits were observed (sp. 29, Figure 6b), but EDX spectra showed their

composition resembles that of the unaffected surface, indicating they were not corrosion products. The expected corrosion products for steel in a solution containing hydrogen carbonate and carbonate ions, in addition to iron oxides, are carbonate species such as siderite (FeCO_3) and magnetite (Fe_3O_4) [52,53], but we did not detect any of these species. Increased Al content was detected in some locations (sp. 23, Figure 6d). Large crystalline deposits, similarly to those observed on NiTi wires, contained equimolar amounts of K and Cl (Figure 6c), indicating KCl precipitation.

Some black pits contained large amounts of C (e.g., Spectrum 21, Figure 6b), indicating the formation of carbides [54]. However, in general, the EDX results of the areas encompassing black pits were not substantially different from those of the areas depleted from pits. Liu et al. [55] studied chemical composition around the pits on SS and found that the majority of pits have the identical composition to the bulk steel. Additionally, the corrosion resistance of the type of steel the brackets are made of (SS 1.4301, AISI 304) is classified as fair to good in various environments [56], but it is well known that pitting corrosion is most aggressive in solutions containing chloride ions, and frequently occurs in the oral cavity [54,57–61]. Hence, the observations made solely on the basis of the SEM micrographs, indicating the onset of pitting corrosion on the brackets even before the

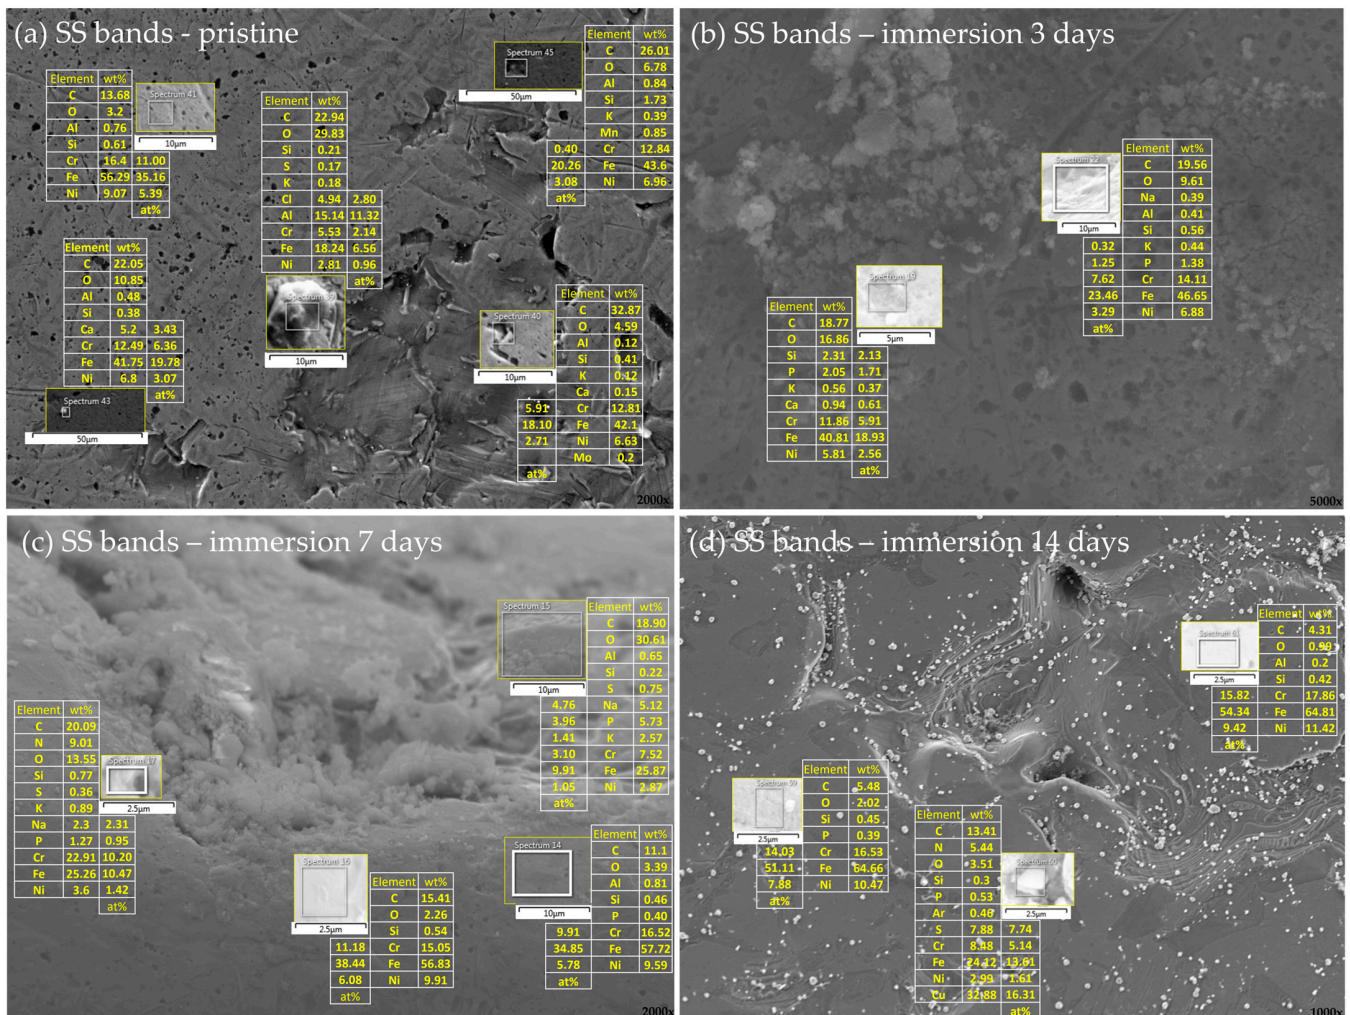
Figure 7. Elemental analysis of the band's surface in an (a) as-received state and after (b) 3 days, (c) 7 days, and (d) 14 days of immersion in artificial saliva. Smaller images show a magnified view of representative surface areas/deposits/precipitates seen in the background image. The tables next to the smaller images show the respective elemental compositions, expressed as wt% for all the elements and at% for those most relevant. In the right corner of every part of a figure is a magnification.

immersion in AS, cannot be rejected. Similar results were obtained for the SS bands in the pristine state (Figure 7a).

EDX analysis of the bands after immersion revealed higher amounts of oxygen compared to the brackets, indicating the formation of an oxide layer, which is consistent with the results of qualitative SEM analysis. The Al-rich deposits were also found (e.g., sp. 39, Figure 7a), but—contrarily to NiTi archwires and SS brackets—no KCl precipitates were observed. Small amounts of Ca-rich entities were found (e.g., sp. 43, Figure 7a), which might occur due to physical adsorption of calcium ions to the oxide layer [62]. An increased quantity of phosphorous atoms was observed, which could indicate the formation of phosphate deposits, which were not observed on archwires and brackets.

EDX analysis further disclosed the presence of metals not listed in the nominal composition of the bands, namely Cu (sp. 60, Figure 7d). A plausible explanation for the presence of copper might be found in the fact that Cu is a component of silver solder alloy, which is still the most commonly used soldering alloy in orthodontics [63,64]. Note that the SS bands are made of SS 1.4303 and SS 1.4551, with the latter being the filler metal. Copper(II) phosphate deposits were observed by Wendl et al. [8] on the bands with attachments from the same manufacturer.
