Source / Izvornik: **Materials**, 2023, 16

Cytotoxicity of Metal Ions Released from NiTi and Stainless Steel Orthodontic Appliances, Part 1: Surface Morphology and Ion Release Variations

Keywords: orthodontic appliances; ion elution; surface properties; NiTi; stainless steel; ligatures; brackets; bands

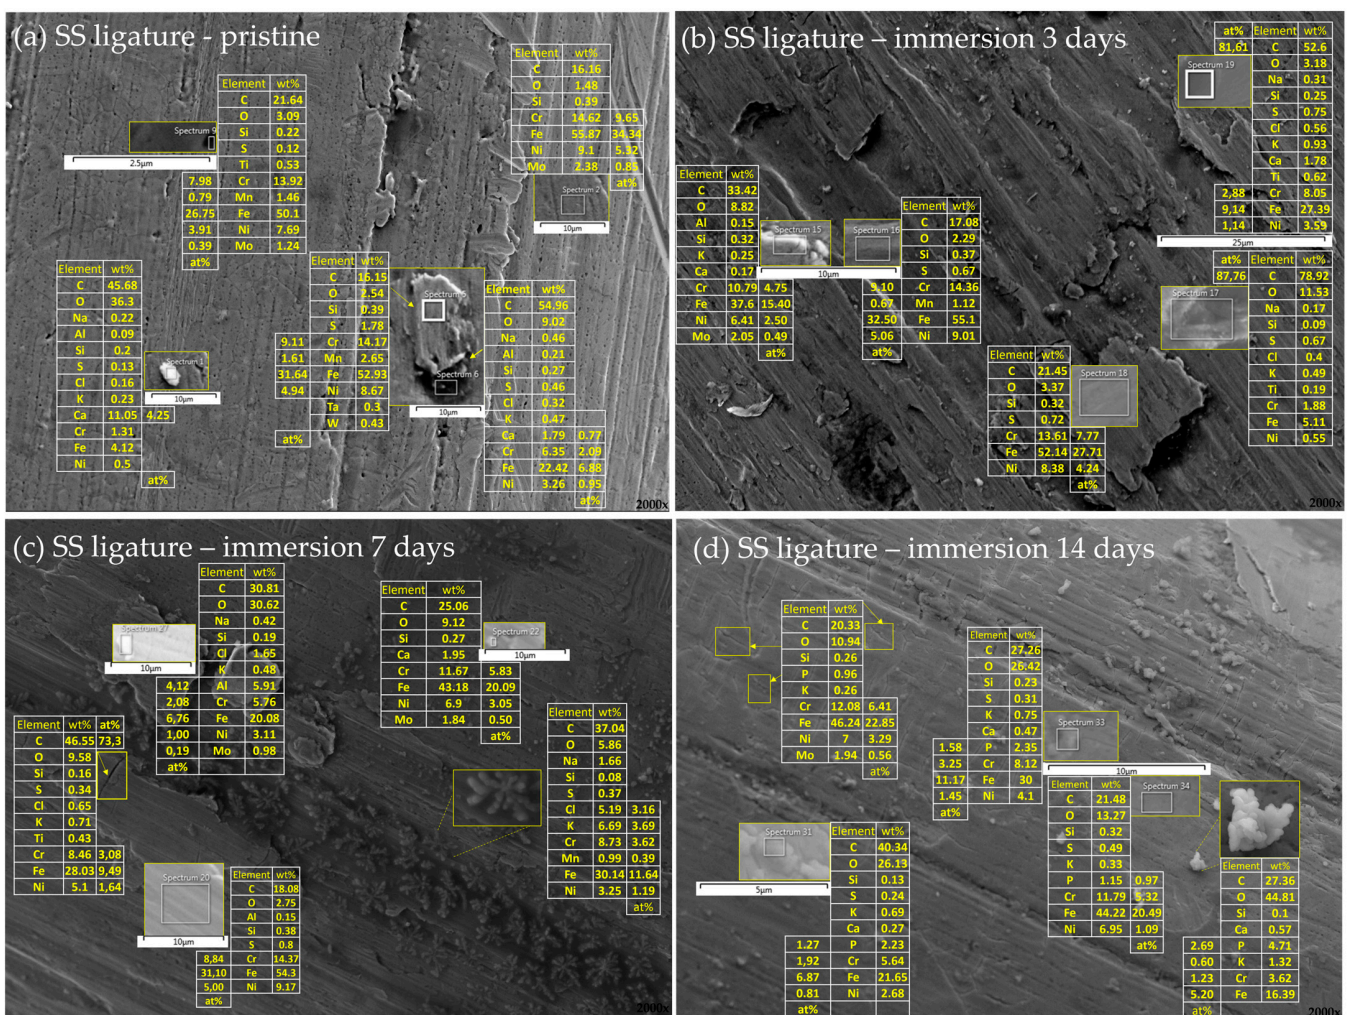
Figure 8. Elemental analysis of the ligatures surface in an (a) as-received state and after (b) 3 days, (c) 7 days, and (d) 14 days of immersion in artificial saliva. Smaller images show a magnified view of representative surface areas/deposits/precipitates seen in the background image. The tables next to the smaller images show the respective elemental compositions, expressed as wt% for all the elements and at% for those most relevant. In the right corner of every part of a figure is a magnification.

The elemental composition of the unaffected areas on the surface of the ligatures reflected the composition of the bulk. Ca-rich deposits were again observed, but were now accompanied by increased amounts of C and O, suggesting the formation of calcium carbonate. Compared to the brackets and bands, an increased number of sites containing extraordinary amounts of carbon were observed (sp. 17 and 19, Figure 8b; sp. 6, Figure 8a; etc.), but not in the form of pits as seen on the surface of the brackets (Figure 6b). Crystals with a peculiar morphology were observed in the striation after 7-day immersion (Figure 8c). Alongside the usual bulk elements, the EDX of these crystals showed equimolar amounts of K and Cl, indicating the formation of KCl crystals also on the surface of the ligatures, but—in contrast to KCl-rich deposits on archwires and bands—their morphology on the ligatures was markedly different. A multitude of crystal morphologies has been found for salivary crystals [37], including rectangular, polyhedral, ovoid, and rod-like, with the latter describing well the morphology seen on Figure 8c.

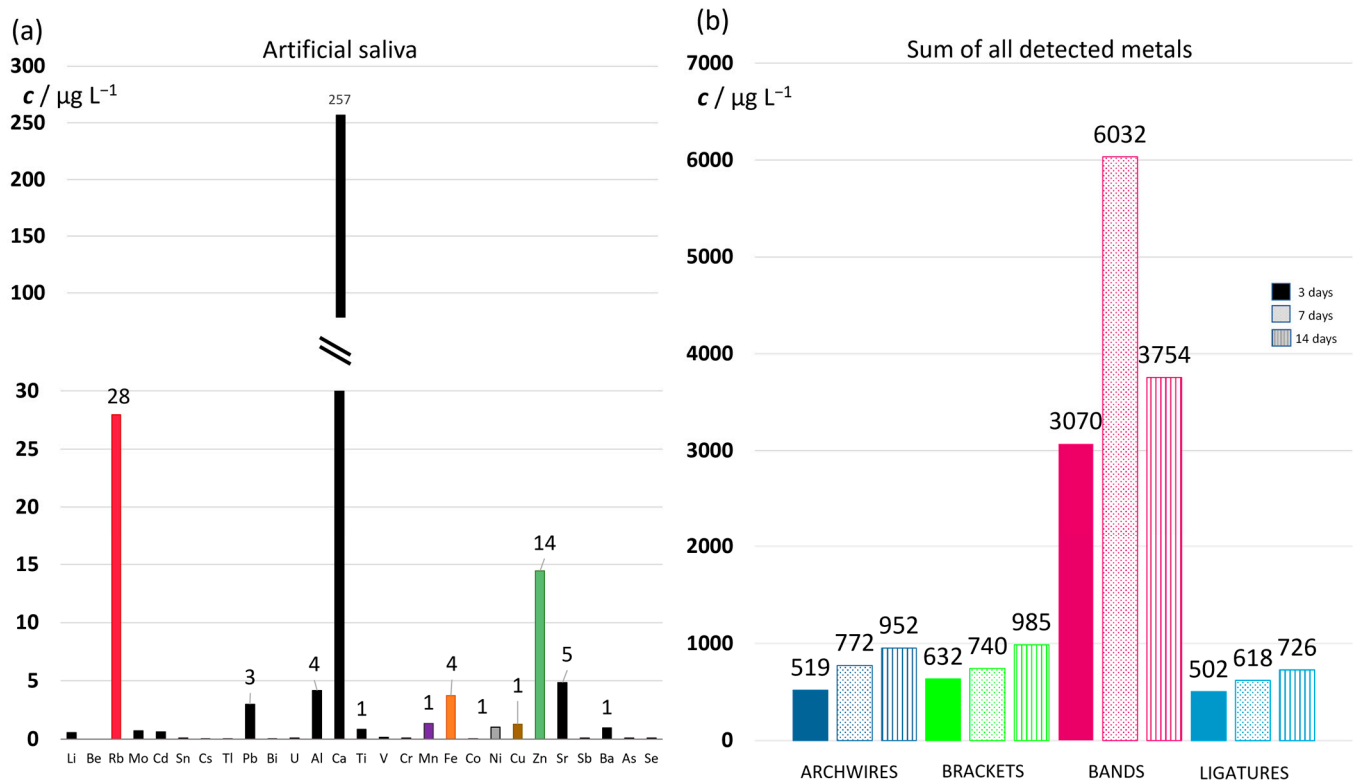
Figure 10. (a) The concentrations of the most abundant ions found in artificial saliva; (b) the sum of concentrations of all detected metals in archwires, brackets, bands, and ligatures after 3-, 7-, and 14-day immersion in artificial saliva at 37 °C.

The ion release results indicated differences between the appliances, even between those made of similar alloys, and demonstrated that the eluted concentrations of the most abundant ion for a particulate appliance (i.e., Ni for NiTi wires, Fe for SS appliances) obtained extreme values on day 7. In order to obtain additional information that could help elucidate this feature, surface roughness measurements were performed on the samples after 7 days of immersion.
