# Cytotoxicity of Metal Ions Released from NiTi and Stainless Steel Orthodontic Appliances, Part 1: Surface Morphology and Ion Release Variations

Source / Izvornik: **Materials**, 2023, 16

**Keywords:** orthodontic appliances; ion elution; surface properties; NiTi; stainless steel; ligatures; brackets; bands

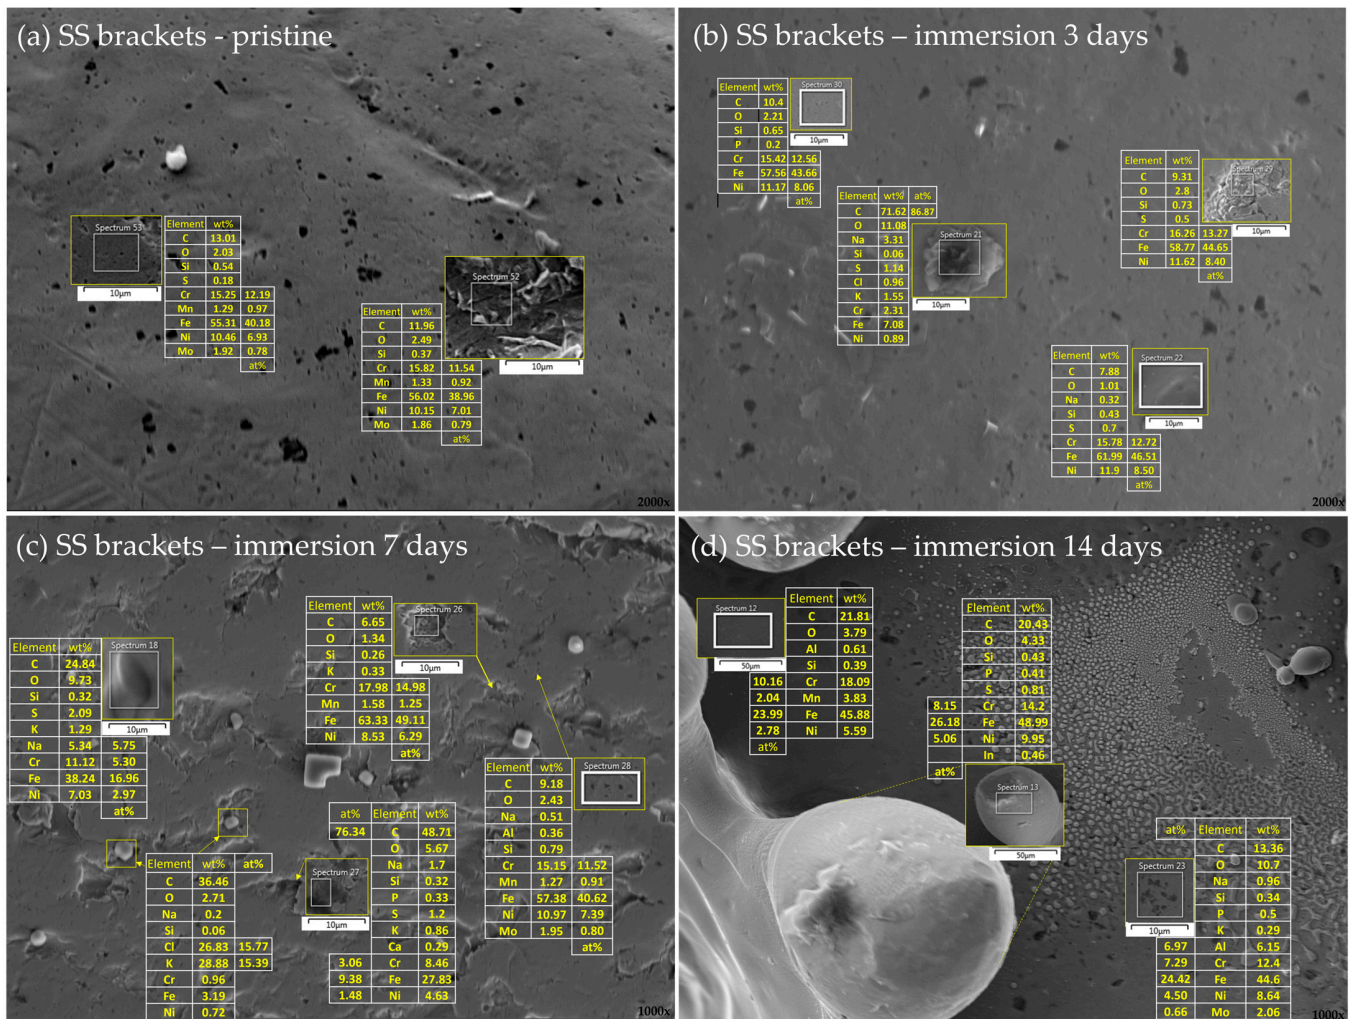
**Figure 6.** Elemental analysis of the bracket's surface in an (a) as-received state and after (b) 3 days, (c) 7 days, and (d) 14 days of immersion in artificial saliva. Smaller images show a magnified view of representative surface areas/deposits/precipitates seen in the background image. The tables next to the smaller images show the respective elemental compositions, expressed as wt% for all the elements and at% for those most relevant. In the right corner of every part of a figure is a magnification.

The SEM qualitative assessment of the surfaces of the SS brackets (Figures 1c,d, 2c,d and 3c,d) revealed numerous sub-micrometer-sized pits, larger irregularly shaped cavities, and large crystalline formations. EDX analysis of the unaffected areas (sp. 53, Figure 6a; sp. 12, Figure 6d) showed that the surface composition of those areas reflected the nominal alloy composition (Table 1). EDX spectra from the bottom of the large cavities (sp. 52, Figure 6a; sp. 26, Figure 6c) gave the equivalent result, which—together with visual assessment—indicated that those are not corrosion cavities, but most likely the consequence of polishing on that side of the bracket. The amounts of accompanying oxygen were such that the formation of protective oxide layer can be ruled out. After 3-day immersion, local hill-like deposits were observed (sp. 29, Figure 6b), but EDX spectra showed their

composition resembles that of the unaffected surface, indicating they were not corrosion products. The expected corrosion products for steel in a solution containing hydrogen carbonate and carbonate ions, in addition to iron oxides, are carbonate species such as siderite ( $\text{FeCO}_3$ ) and magnetite ( $\text{Fe}_3\text{O}_4$ ) [52,53], but we did not detect any of these species. Increased Al content was detected in some locations (sp. 23, Figure 6d). Large crystalline deposits, similarly to those observed on NiTi wires, contained equimolar amounts of K and Cl (Figure 6c), indicating KCl precipitation.

Some black pits contained large amounts of C (e.g., Spectrum 21, Figure 6b), indicating the formation of carbides [54]. However, in general, the EDX results of the areas encompassing black pits were not substantially different from those of the areas depleted from pits. Liu et al. [55] studied chemical composition around the pits on SS and found that the majority of pits have the identical composition to the bulk steel. Additionally, the corrosion resistance of the type of steel the brackets are made of (SS 1.4301, AISI 304) is classified as fair to good in various environments [56], but it is well known that pitting corrosion is most aggressive in solutions containing chloride ions, and frequently occurs in the oral cavity [54,57–61]. Hence, the observations made solely on the basis of the SEM micrographs, indicating the onset of pitting corrosion on the brackets even before the

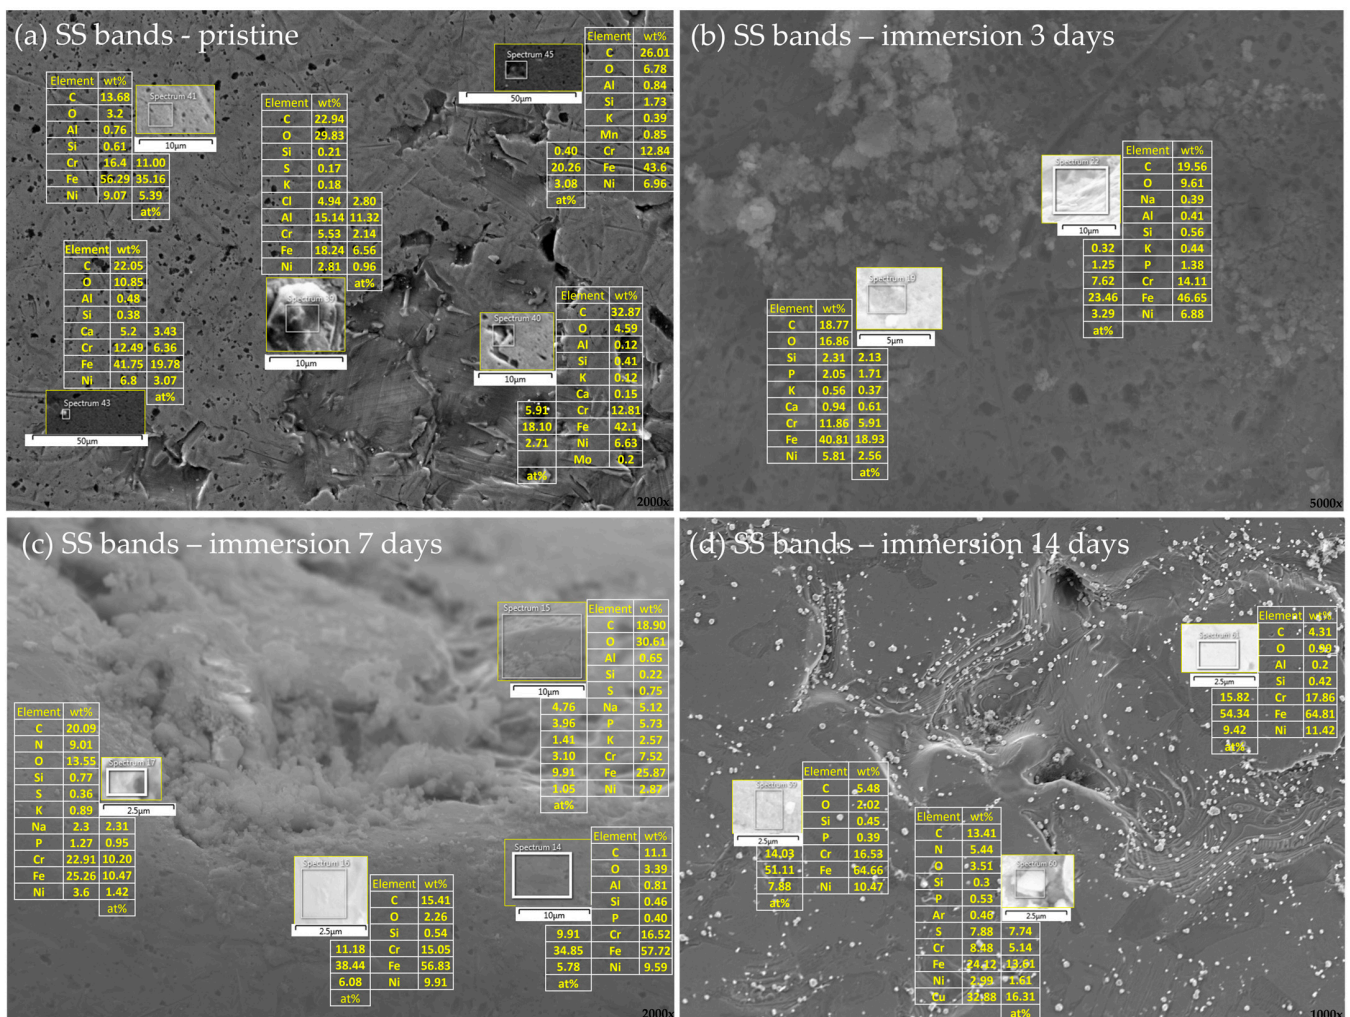
**Figure 7.** Elemental analysis of the band's surface in an (a) as-received state and after (b) 3 days, (c) 7 days, and (d) 14 days of immersion in artificial saliva. Smaller images show a magnified view of representative surface areas/deposits/precipitates seen in the background image. The tables next to the smaller images show the respective elemental compositions, expressed as wt% for all the elements and at% for those most relevant. In the right corner of every part of a figure is a magnification.

immersion in AS, cannot be rejected. Similar results were obtained for the SS bands in the pristine state (Figure 7a).

EDX analysis of the bands after immersion revealed higher amounts of oxygen compared to the brackets, indicating the formation of an oxide layer, which is consistent with the results of qualitative SEM analysis. The Al-rich deposits were also found (e.g., sp. 39, Figure 7a), but—contrarily to NiTi archwires and SS brackets—no KCl precipitates were observed. Small amounts of Ca-rich entities were found (e.g., sp. 43, Figure 7a), which might occur due to physical adsorption of calcium ions to the oxide layer [62]. An increased quantity of phosphorous atoms was observed, which could indicate the formation of phosphate deposits, which were not observed on archwires and brackets.

EDX analysis further disclosed the presence of metals not listed in the nominal composition of the bands, namely Cu (sp. 60, Figure 7d). A plausible explanation for the presence of copper might be found in the fact that Cu is a component of silver solder alloy, which is still the most commonly used soldering alloy in orthodontics [63,64]. Note that the SS bands are made of SS 1.4303 and SS 1.4551, with the latter being the filler metal. Copper(II) phosphate deposits were observed by Wendl et al. [8] on the bands with attachments from the same manufacturer.

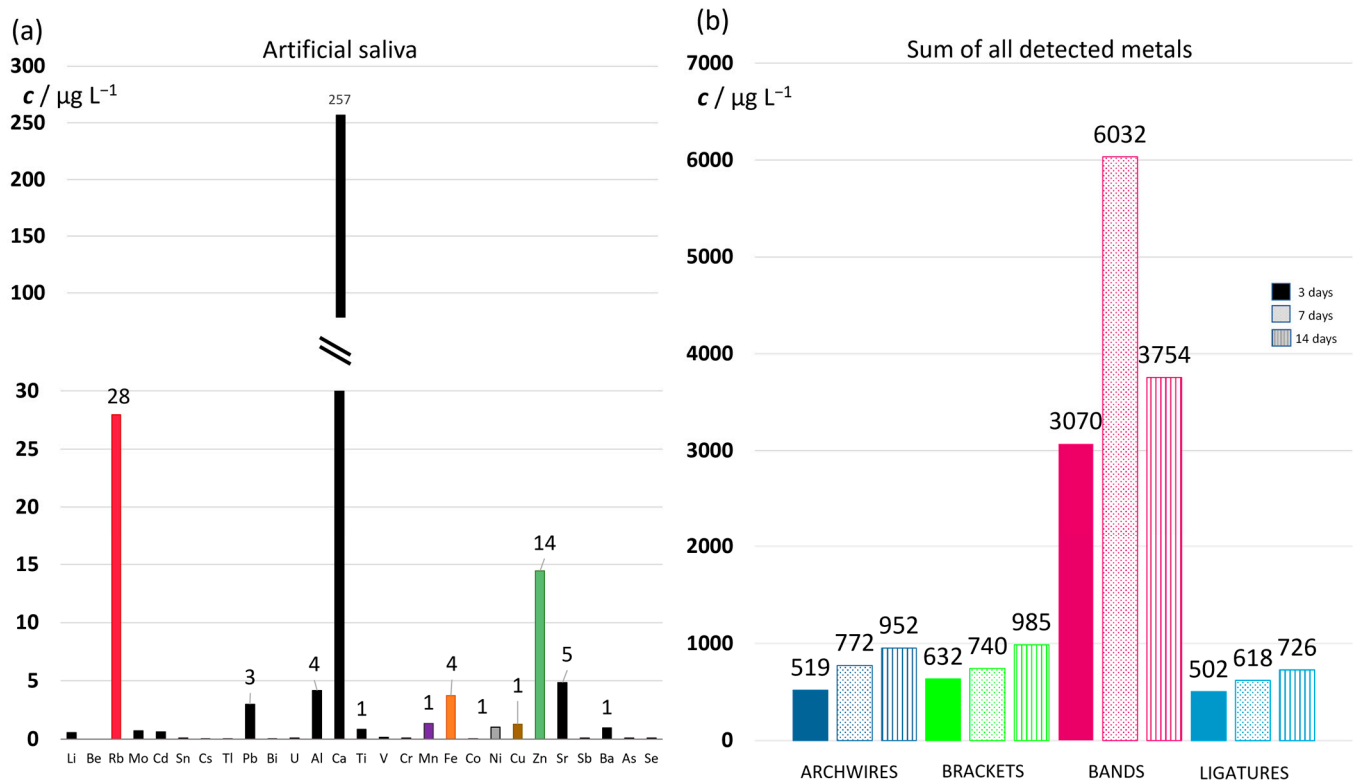
**Figure 10.** (a) The concentrations of the most abundant ions found in artificial saliva; (b) the sum of concentrations of all detected metals in archwires, brackets, bands, and ligatures after 3-, 7-, and 14-day immersion in artificial saliva at 37 °C.
