Sacrospinous ligament insufficiency fractures - a commonly overlooked cause of low back and pelvic pain ; a case report and literature review

Source / Izvornik: **Reumatizam**, 2020, **67**, 107 - 117

SACRAL INSUFFICIENCY FRACTURES – A COMMONLY OVERLOOKED CAUSE OF LOW BACK AND PELVIC PAIN; A CASE REPORT AND LITERATURE REVIEW

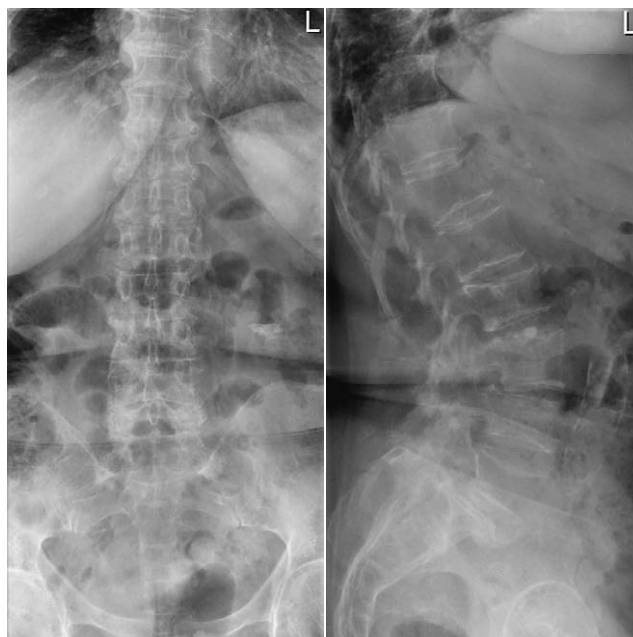
FIGURE 1. Radiographs of the LS spine showed vertebral compression fracture of the second lumbar vertebra (L2) (grade II according to the Genant classification of vertebral fractures) with diffuse degenerative changes, hypertrophic osteoarthropathy of intervertebral joints at the L3–S1 level, and signs of skeletal osteopenia.

Bone densitometry (DXA) findings showed osteoporosis with a measured T-value of -5.4 at the spine, at the vertebral level L1 – L4, and -3.0 at the left hip in total, which confirmed the diagnosis of severe osteoporosis with vertebral compression fracture of the second lumbar vertebra (L2).

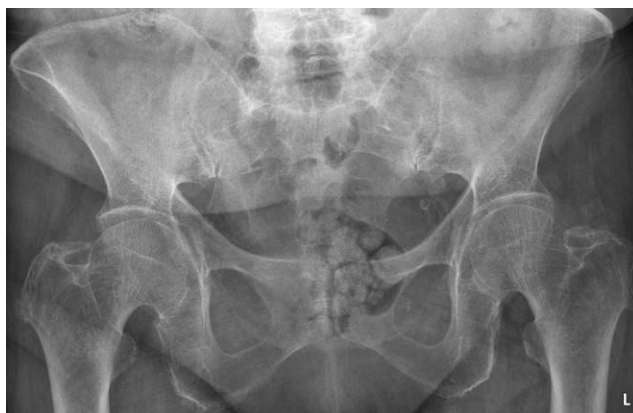
FIGURE 2. Plain radiograph of the pelvis showed signs of femoroacetabular impingement and bone spurs at the muscle attachments to the pelvic girdle.

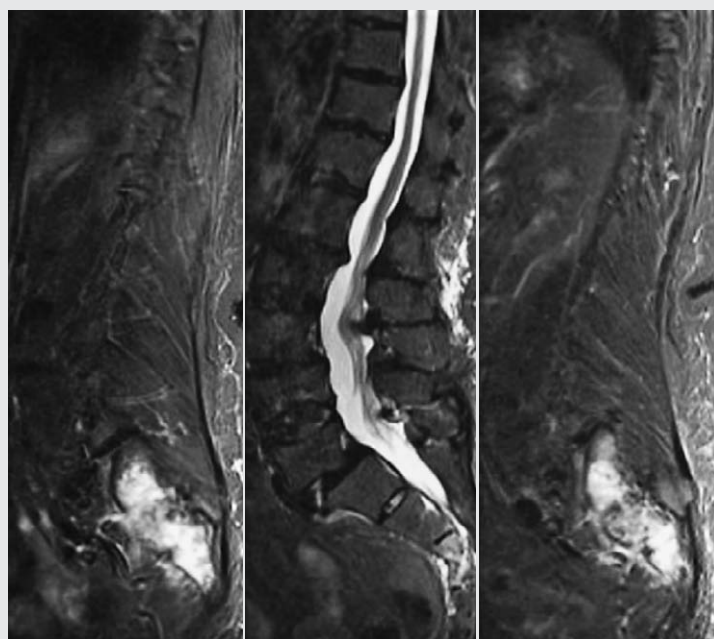
FIGURE 3. Pathologically increased signal of lateral masses of the sacrum shown on the MRI of the LS spine. Sagittal sections through the LS spine (STIR image) show a pathological increase in the signal of the lateral masses of the sacrum along with signs of discopathy and foraminal stenosis along the lumbar level of the spine.

Typical signs of fracture that were visible on the MRI were bone marrow oedema and fracture gaps. Fracture gaps are most visible in sequences in T1 (spin-lattice) relaxation time. Bone marrow oedema is presented as a region of high intensity in sequences in T2 (spin-spin) relaxation time with fat suppression and in STIR sequences, as well as a region of low intensity in sequences in T1 (spin-lattice) relaxation time in relation to the surrounding normal bone. MRI has an almost 100% sensitivity for detecting spongy bone oedema, but it is a relatively nonspecific sign present in various bone-related pathological conditions, ranging from reactive oedema due to mechanical stress, oedema related to postconcussional syndrome, to processes related to inflammation and tumours (15). During the interpretation of MRI findings, it should be taken into account that a fracture gap is not always visible and that diagnostic errors are possible, especially in patients with malignant diseases. However, in almost 90% of insufficiency fractures, bone marrow oedema and fracture gaps are present at the same time (15).

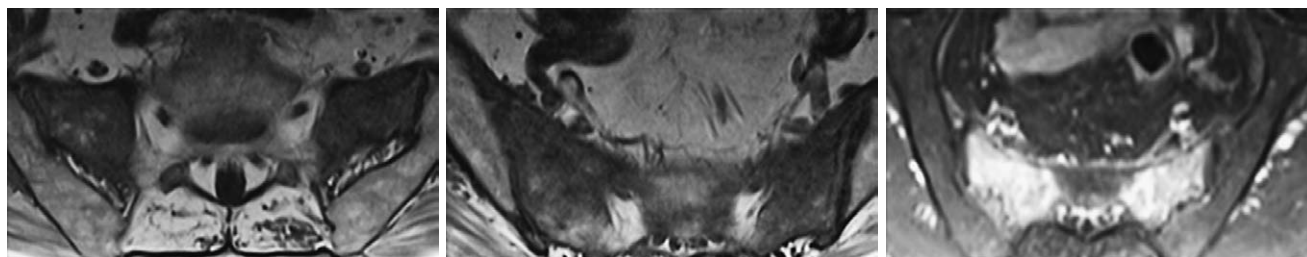
FIGURE 4. On the T1-weighted image, axial sections through the sacrum show linear zones of low signal intensity, which can be seen bilaterally in the areas extending through lateral masses of the sacrum and which correspond to fracture lines. The extensive high signal zones in the STIR image (last image on the right) correspond to the oedema of the surrounding spongy bone. No pathological changes of the SI joints were observed.
