# Cytotoxicity of Metal Ions Released from NiTi and Stainless Steel Orthodontic Appliances, Part 1: Surface Morphology and Ion Release Variations

*Source / Izvornik:* **Materials, 2023, 16**

**Journal article, Published version**

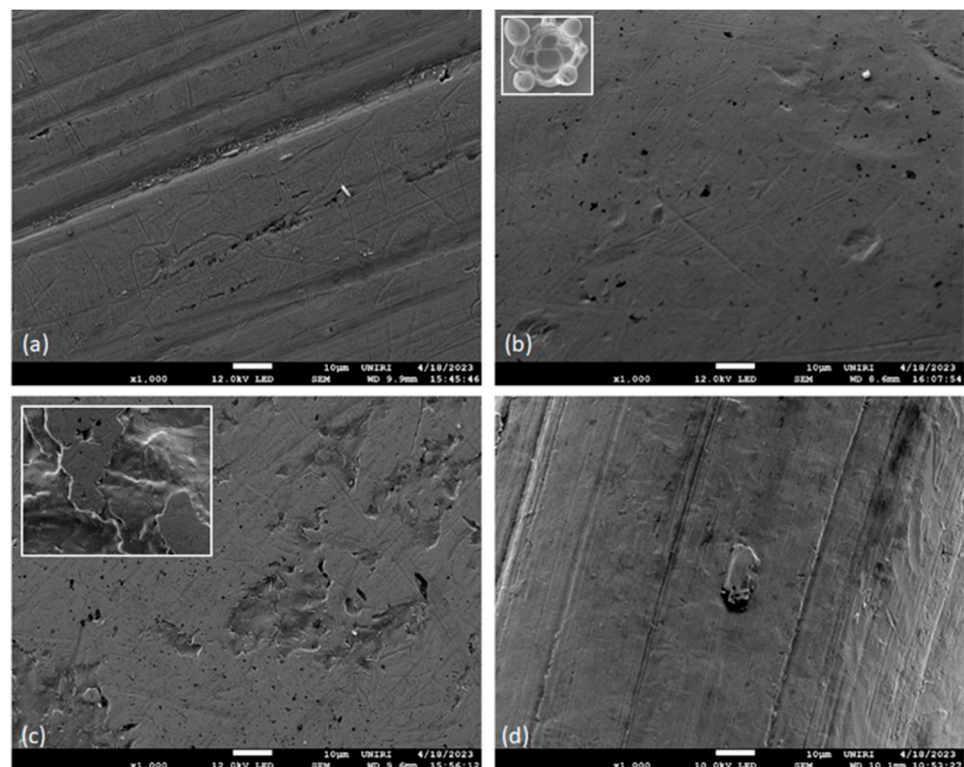
**Figure 1.** Representative SEM micrographs of (a) NiTi archwires, (b) stainless steel (SS) brackets, (c) SS bands and (d) SS ligatures, before immersion in artificial saliva.

The surface of the brackets and the bands (Figure 1b,c) contained other types of heterogeneities, most notably the black spots/pits ranging from submicron to several microns in size. The spots resembled corrosion cavities, thus indicating that the corrosion process has started before the immersion in artificial saliva. The onset of pitting corrosion on new orthodontic appliances has been reported in other studies as well [9,25]. On the other hand, no corrosion pits were noticed on the NiTi wires and ligatures, even though the ligatures were made of a very similar type of SS as the brackets (Table 1). Data obtained from the manufacturer confirmed that no coatings or additives were used on the ligatures (private correspondence); hence, the differences probably arose from variations in the manufacturing process. Indeed, it has been demonstrated that the polishing of NiTi wires to a uniform finish reduces the corrosion rate [9,26].

Alongside the corrosion pits, the brackets contained very few other morphological features, except numerous flower-like formations on the underside (depicted in the addendum in Figure 1b), arranged in a formation that reflected one of the possible shapes of the base morphology [27], with a purpose of improving the adhesion to the tooth [28]. The bands (Figure 1c) contained large, irregularly shaped cavities several tens of micrometers in size, with smooth areas in between. The lower side (the addendum in Figure 1c) contained a markedly smaller proportion of smooth areas. The differences between the two sides, also visible macroscopically, are the result of intentionally lower polishing level of the lower side, again to improve the adhesion to the tooth.

The SEM micrographs also showed that all parts except the ligatures contained small amounts of approximately micrometer-sized white crystal deposits. Similar impurities were found in other studies, located in the corrosion pits [25] or elsewhere on the surface [29].

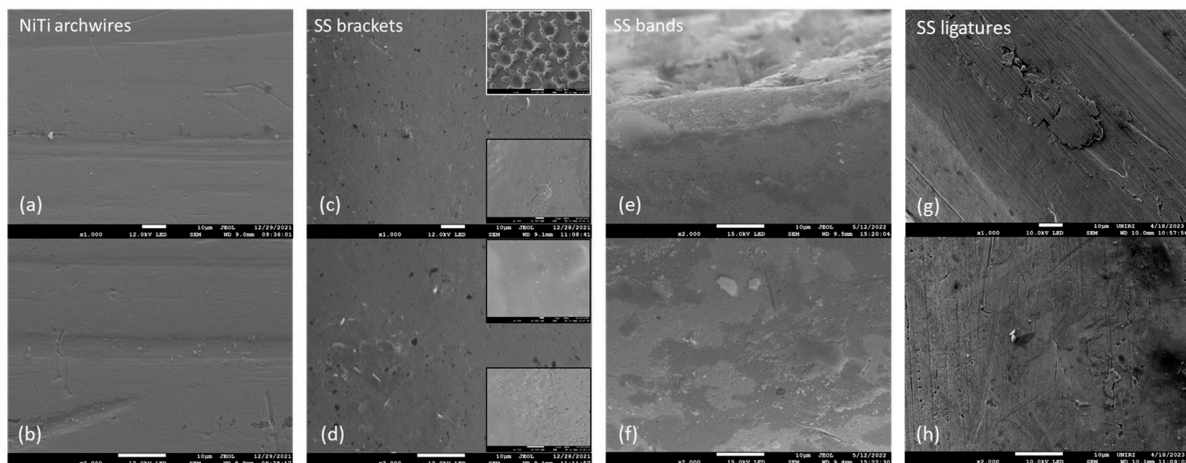
**Figure 2.** Representative lower magnification (top row) and higher magnification (bottom row) SEM micrographs of (a,b) NiTi archwires, (c,d) stainless steel brackets (SS), (e,f) SS bands, and (g,h) SS ligatures, after 3 days of immersion in artificial saliva.

Three days of immersion did not notably enhance the pitting corrosion in SS brackets, nor did it result in deposits or adherent material. However, the protrusion of crystal clusters from the bulk was observed. Higher magnification images (representative image given as upper addendum in Figure 2d) further indicated that the small white entities were not the adhering material. Besides those, the lower bracket surface, containing areas of various morphologies (addendums in Figure 2c,d), also showed no notable changes.

On the contrary, the SEM micrographs of SS bands (Figure 2e,f) showed prominent changes and a very small portion of the unaffected surface. Most of the surface was covered with an adherent layer that was not detected on other parts of the fixed appliance. This layer can be recognized as an oxide protective layer, which is common on SS products [30–33]. Lighter colored deposits were observed on the top of the protective layer and in the areas in between, which were reminiscent of layer debris [34].

Black pits were visible on the surface of SS ligatures (Figure 2g,h), indicating the onset of corrosion. An increased number of white crystal precipitates was also observed.

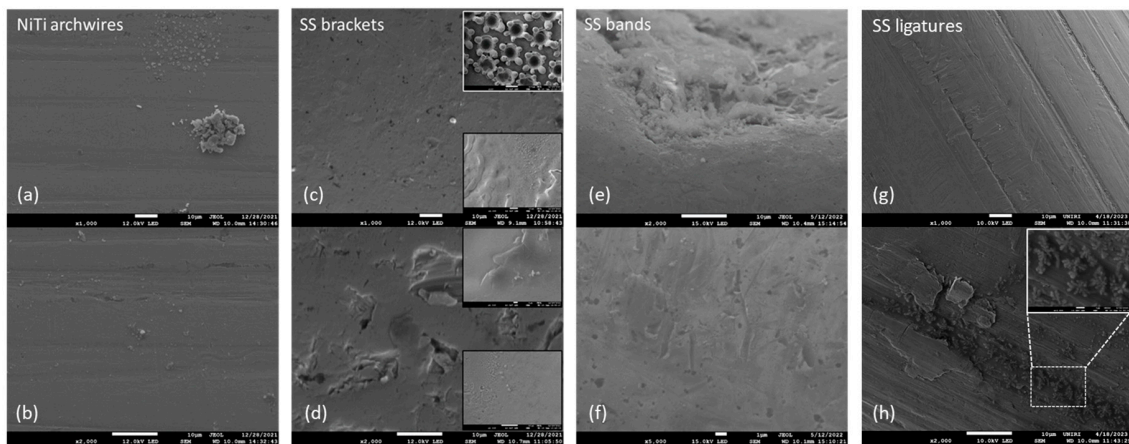
**Figure 3.** Representative lower magnification (top row) and higher magnification (bottom row) SEM micrographs of (a,b) NiTi archwires, (c,d) stainless steel brackets (SS), (e,f) SS bands, and (g,h) SS ligatures, after 7-day immersion in artificial saliva.

After 7-day immersion, no signs of localized corrosion or oxide layer formation were observed on the NiTi surface (Figure 3a,b). The quantity of deposits increased, both in number and size.

SEM micrographs (Figure 3c,d) indicated changes on the surface of SS brackets. Two main features were observed on the upper surface: the large amount of irregularly shaped large cavities ( $>10\ \mu\text{m}$ ) and large, regularly shaped crystal deposits, up to  $10\ \mu\text{m}$  in size. The lower surface appeared to be less affected, as indicated by the addendums on Figure 3c,d. The amount and the size of the corrosion pits appeared similar to those observed after 3-day immersion.

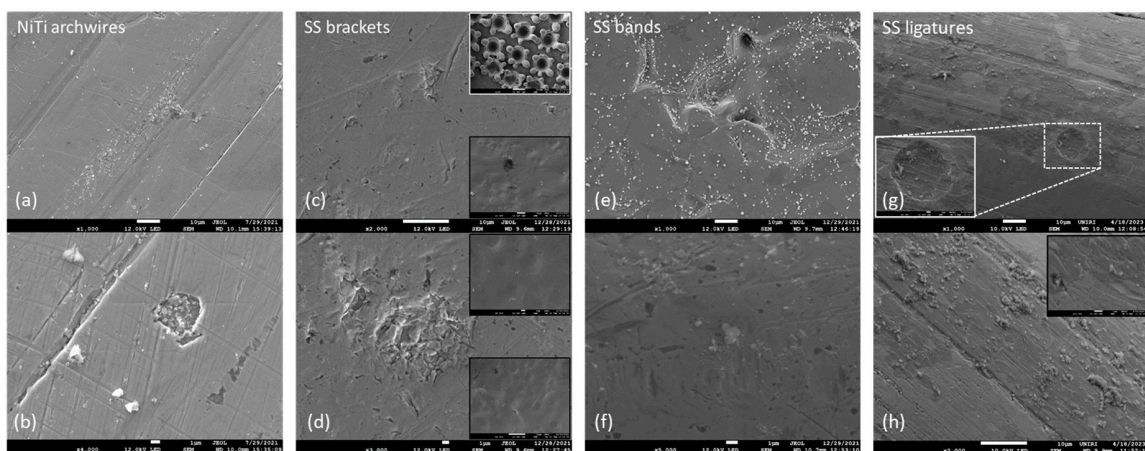
**Figure 4.** Representative lower magnification (top row) and higher magnification (bottom row) SEM micrographs of (a,b) NiTi archwires, (c,d) stainless steel (SS) brackets, (e,f) SS bands, and (g,h) SS ligatures, after 14-day immersion in artificial saliva.

After 14-day immersion, development was observed on the surface of the NiTi archwires (Figure 4a,b). New crevices and grooves were formed, and the surface—both on the inside and the outside of the surface irregularities—was abundant with white precipitates/deposits of various sizes. No signs of pitting corrosion were observed.

Pitting corrosion appeared to be slightly advanced on the SS bracket surface (Figure 4c,d), but this should be confirmed by quantitative methods. For comparison, Frois et al. [31] found no relevant morphological changes on the surface even after 30 days of immersion. New deposits of specific morphology formed, having a size of a few tens of micrometers. Larger white crystal deposits were rare and located on the underside of the bracket (addendums Figure 4c,d). Deposits also occurred on flower-like structures (upper addendum on Figure 4c).

Results for the SS bands showed a drastic increase in the number of white precipitates (Figure 4e). The protective layer (Figure 4f) appeared similar to that observed after 7-day immersion (Figure 3f).

The surface of the ligatures changed: irregular patches were observed, indicating the formation of the protective layer (Figure 4g,h). Large amounts of debris and precipitates were present, and located on the top of the protective layer, not on the unaffected areas.

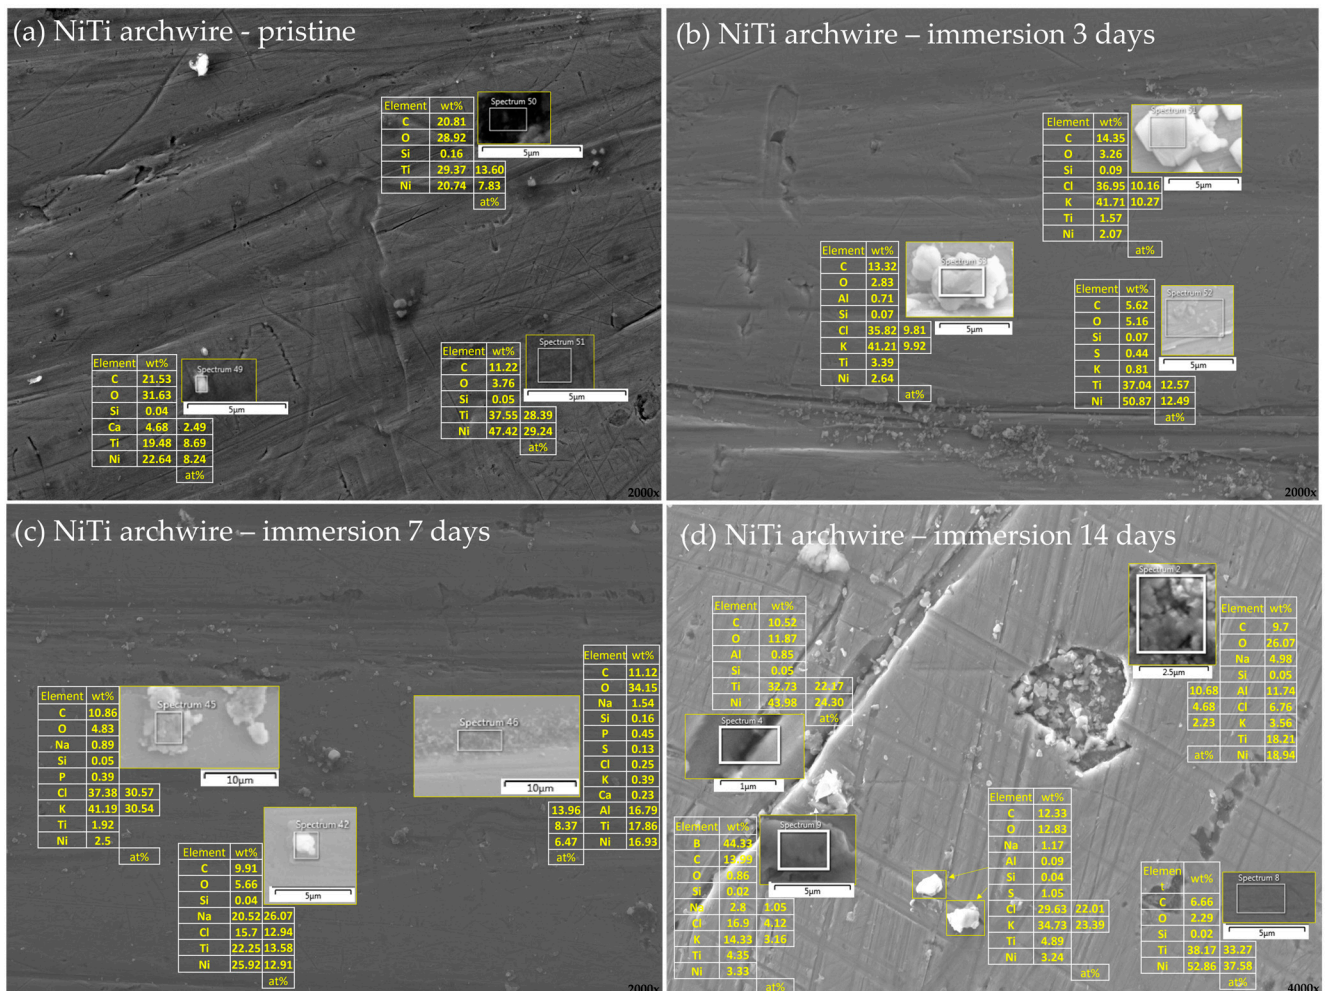
**Figure 5.** Elemental analysis of the archwire surface in an (a) as-received state and after (b) 3 days, (c) 7 days, and (d) 14 days of immersion in artificial saliva. Smaller images show a magnified view of representative surface areas/deposits/precipitates seen in the background image. The tables next to the smaller images show the respective elemental compositions, expressed as wt% for all the elements and at% for those most relevant. In the right corner of every part of a figure is a magnification.

Representative results for the surface of the NiTi archwire are shown in Figure 5. The elemental composition of the smooth unaffected regions (e.g., Spectrum 51, Figure 5a; Spectrum 52, Figure 5b; Spectrum 8, Figure 5d) showed that the ratio of Ni and Ti atomic percentages in these regions was approximately 1:1, indicating that in those areas the surface composition reflects the nominal composition of the alloy (Table 1). Moreover, comparing the relative amounts of Ni and Ti with oxygen for those locations, a very low oxygen level can be observed. Correlating this result with, for example, those reported in a study by Carroll and Kelly [5], it can be inferred that the typical oxide layer [23,24,29,38–41] did not form. This is also in accordance with the SEM results, where the protective layer would be visible due to its specific texture [24]. Note that the results showed that the oxide layer did not form even after 14-day immersion (sp. 8, Figure 5d). As indicated by SEM and confirmed by EDX, the NiTi wires used in this study were obviously depleted of the protective oxide layer, which is done by mechanical polishing [5]. Devices with a mechanically and electrolytically polished NiTi surface are also used as implants [29]. The studies showed that the prevention of Ni release by a thick oxide layer can be inadequate because it led to Ni accumulation below the protective layer, which served as a reservoir for Ni release in the case of surface damage, and led to the onset of pitting corrosion [29,42]. It has been shown that polished NiTi surfaces exhibited improved resistance to localized corrosion attacks in a chloride-rich medium [6].

On some locations, the 2:1 atomic ratio of Ti and Ni was found (sp. 50, Figure 5b). This result implied the formation of  $Ti_2Ni$  phase, which typically occurs in NiTi wires [19,38,43,44]. Increased carbon content was observed in some locations, which could theoretically indicate the formation of the titanium carbide [38,41,45,46], but it is less likely due to the above-given reasons regarding carbon measurements with EDX. The dark grains of pure Ti, observed in some studies [6], were not found in our samples.

EDX analysis also revealed that the large crystallites observed on the NiTi surface consisted of equimolar amounts of K and Cl (sp. 51 and 53, Figure 5b; sp. 45, Figure 5c and yellow squared parts, Figure 5d), indicating the precipitation of potassium chloride crystals. In some cases (sp. 9, Figure 5d), the results implied that part of the  $K^+$  ions was exchanged with  $Na^+$ . Potassium chloride is a highly soluble salt (~39 g per 100 g  $H_2O$  at 37 °C) and was observed only on samples after immersion; hence, it can be inferred that the crystals formed after the evaporation of artificial saliva. Eliades et al. [47] reported the formation of microcrystalline KCl and NaCl deposits as well, on the surface of NiTi wires taken after 1–6 months in vivo, which substantially altered the surface composition and topography. Note that the artificial saliva used in our study contained potassium chloride and other potassium and sodium salts (vide supra, Section 2.2).

The crystals on the as-received NiTi samples contained elevated amounts of calcium ions (sp. 49, Figure 5a), accompanied by relatively high amounts of C and O, which might suggest the formation of calcium carbonate. Alongside large white precipitates, other types of deposits could be distinguished. The EDX analysis of smaller gray entities (<0.5  $\mu m$ ), distributed over wide areas as clusters or individually, showed equimolar amounts of Ni and Ti (sp. 52, Figure 5b) with low oxygen content, confirming them as manufacturing debris. Calcium phosphate deposits, found in previous studies after NiTi immersion in phosphate-containing solutions [6,23,48], were not detected on our samples.

Elemental analysis also showed that some of the small crystal clusters contained appreciable amounts of aluminum (e.g., Spectrum 46, Figure 5b; Spectrum 2, Figure 5c), accompanied by an increased amount of oxygen, indicating a possible formation of aluminum oxide (alumina). This result is noteworthy because aluminum was not listed in the nominal alloy composition. Yet, in several studies, some amounts of Al were found on the surface of the as-received samples [41], among the released ions in the artificial saliva and in the artificial saliva itself [49], and in the surface precipitates [25]. Moreover, Gravina et al. studied the composition of NiTi wires from six different companies and found  $Al_2O_3$  in all

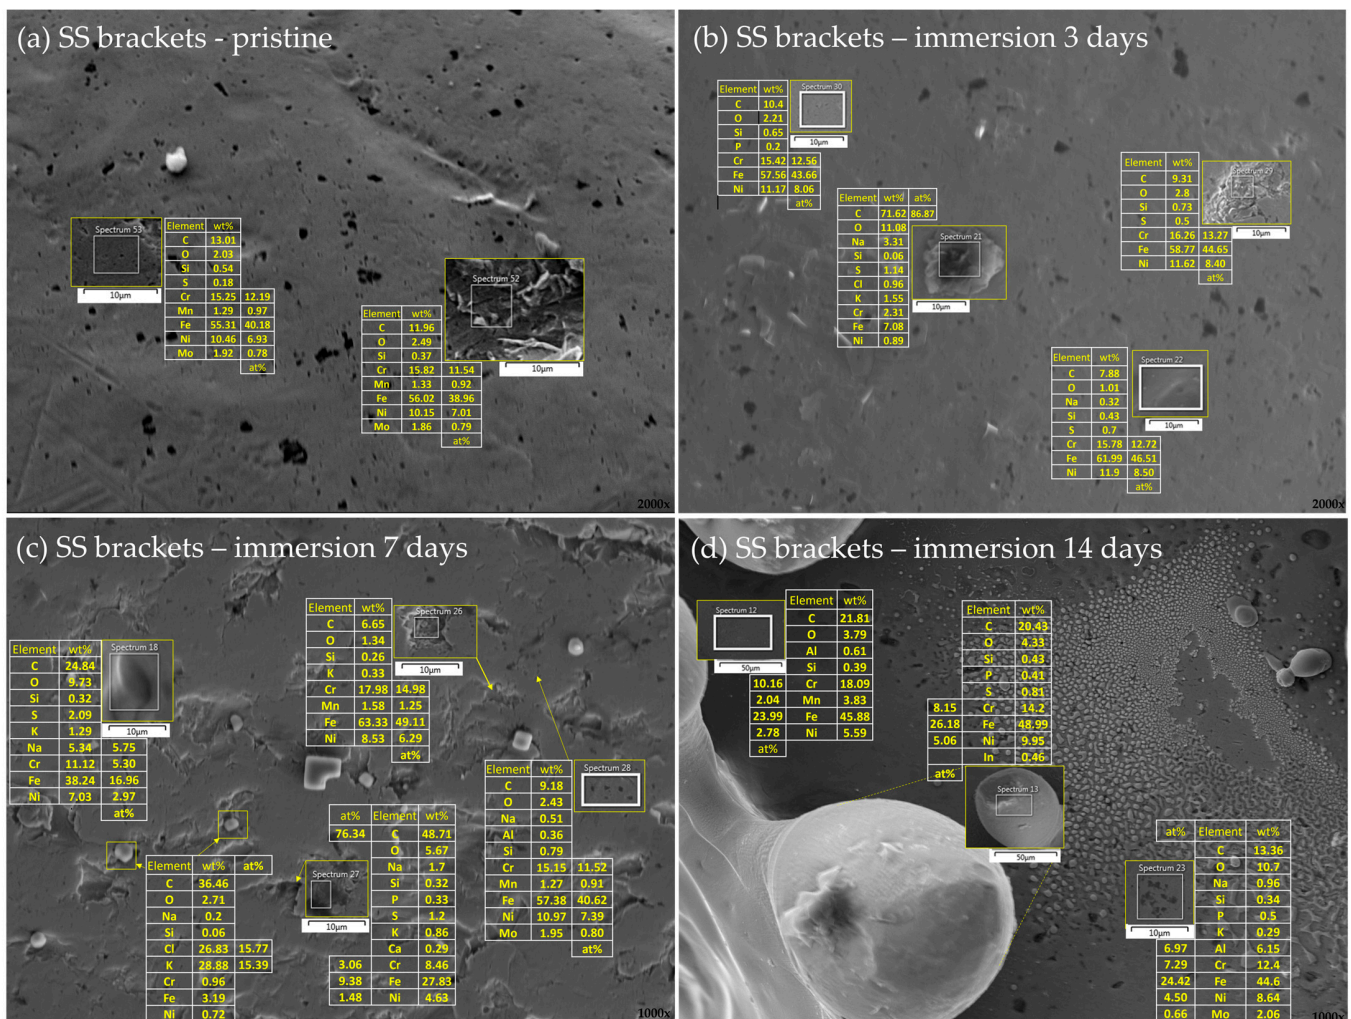
**Figure 6.** Elemental analysis of the bracket's surface in an (a) as-received state and after (b) 3 days, (c) 7 days, and (d) 14 days of immersion in artificial saliva. Smaller images show a magnified view of representative surface areas/deposits/precipitates seen in the background image. The tables next to the smaller images show the respective elemental compositions, expressed as wt% for all the elements and at% for those most relevant. In the right corner of every part of a figure is a magnification.

The SEM qualitative assessment of the surfaces of the SS brackets (Figures 1c,d, 2c,d and 3c,d) revealed numerous sub-micrometer-sized pits, larger irregularly shaped cavities, and large crystalline formations. EDX analysis of the unaffected areas (sp. 53, Figure 6a; sp. 12, Figure 6d) showed that the surface composition of those areas reflected the nominal alloy composition (Table 1). EDX spectra from the bottom of the large cavities (sp. 52, Figure 6a; sp. 26, Figure 6c) gave the equivalent result, which—together with visual assessment—indicated that those are not corrosion cavities, but most likely the consequence of polishing on that side of the bracket. The amounts of accompanying oxygen were such that the formation of protective oxide layer can be ruled out. After 3-day immersion, local hill-like deposits were observed (sp. 29, Figure 6b), but EDX spectra showed their

composition resembles that of the unaffected surface, indicating they were not corrosion products. The expected corrosion products for steel in a solution containing hydrogen carbonate and carbonate ions, in addition to iron oxides, are carbonate species such as siderite ( $\text{FeCO}_3$ ) and magnetite ( $\text{Fe}_3\text{O}_4$ ) [52,53], but we did not detect any of these species. Increased Al content was detected in some locations (sp. 23, Figure 6d). Large crystalline deposits, similarly to those observed on NiTi wires, contained equimolar amounts of K and Cl (Figure 6c), indicating KCl precipitation.

Some black pits contained large amounts of C (e.g., Spectrum 21, Figure 6b), indicating the formation of carbides [54]. However, in general, the EDX results of the areas encompassing black pits were not substantially different from those of the areas depleted from pits. Liu et al. [55] studied chemical composition around the pits on SS and found that the majority of pits have the identical composition to the bulk steel. Additionally, the corrosion resistance of the type of steel the brackets are made of (SS 1.4301, AISI 304) is classified as fair to good in various environments [56], but it is well known that pitting corrosion is most aggressive in solutions containing chloride ions, and frequently occurs in the oral cavity [54,57–61]. Hence, the observations made solely on the basis of the SEM micrographs, indicating the onset of pitting corrosion on the brackets even before the

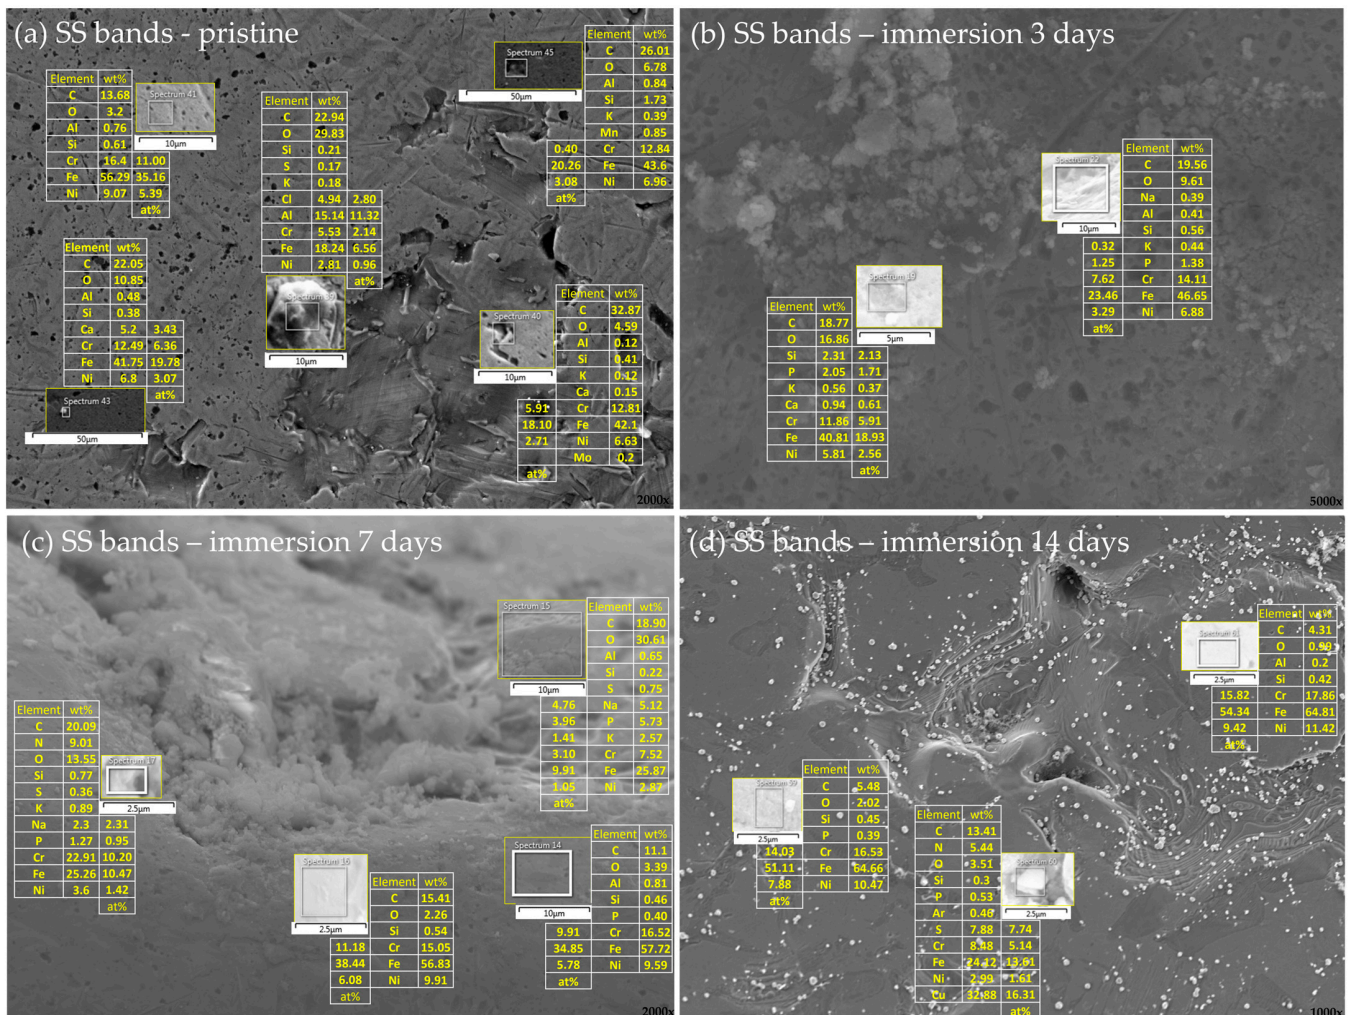
**Figure 7.** Elemental analysis of the band’s surface in an (a) as-received state and after (b) 3 days, (c) 7 days, and (d) 14 days of immersion in artificial saliva. Smaller images show a magnified view of representative surface areas/deposits/precipitates seen in the background image. The tables next to the smaller images show the respective elemental compositions, expressed as wt% for all the elements and at% for those most relevant. In the right corner of every part of a figure is a magnification.

immersion in AS, cannot be rejected. Similar results were obtained for the SS bands in the pristine state (Figure 7a).

EDX analysis of the bands after immersion revealed higher amounts of oxygen compared to the brackets, indicating the formation of an oxide layer, which is consistent with the results of qualitative SEM analysis. The Al-rich deposits were also found (e.g., sp. 39, Figure 7a), but—contrarily to NiTi archwires and SS brackets—no KCl precipitates were observed. Small amounts of Ca-rich entities were found (e.g., sp. 43, Figure 7a), which might occur due to physical adsorption of calcium ions to the oxide layer [62]. An increased quantity of phosphorous atoms was observed, which could indicate the formation of phosphate deposits, which were not observed on archwires and brackets.

EDX analysis further disclosed the presence of metals not listed in the nominal composition of the bands, namely Cu (sp. 60, Figure 7d). A plausible explanation for the presence of copper might be found in the fact that Cu is a component of silver solder alloy, which is still the most commonly used soldering alloy in orthodontics [63,64]. Note that the SS bands are made of SS 1.4303 and SS 1.4551, with the latter being the filler metal. Copper(II) phosphate deposits were observed by Wendl et al. [8] on the bands with attachments from the same manufacturer.

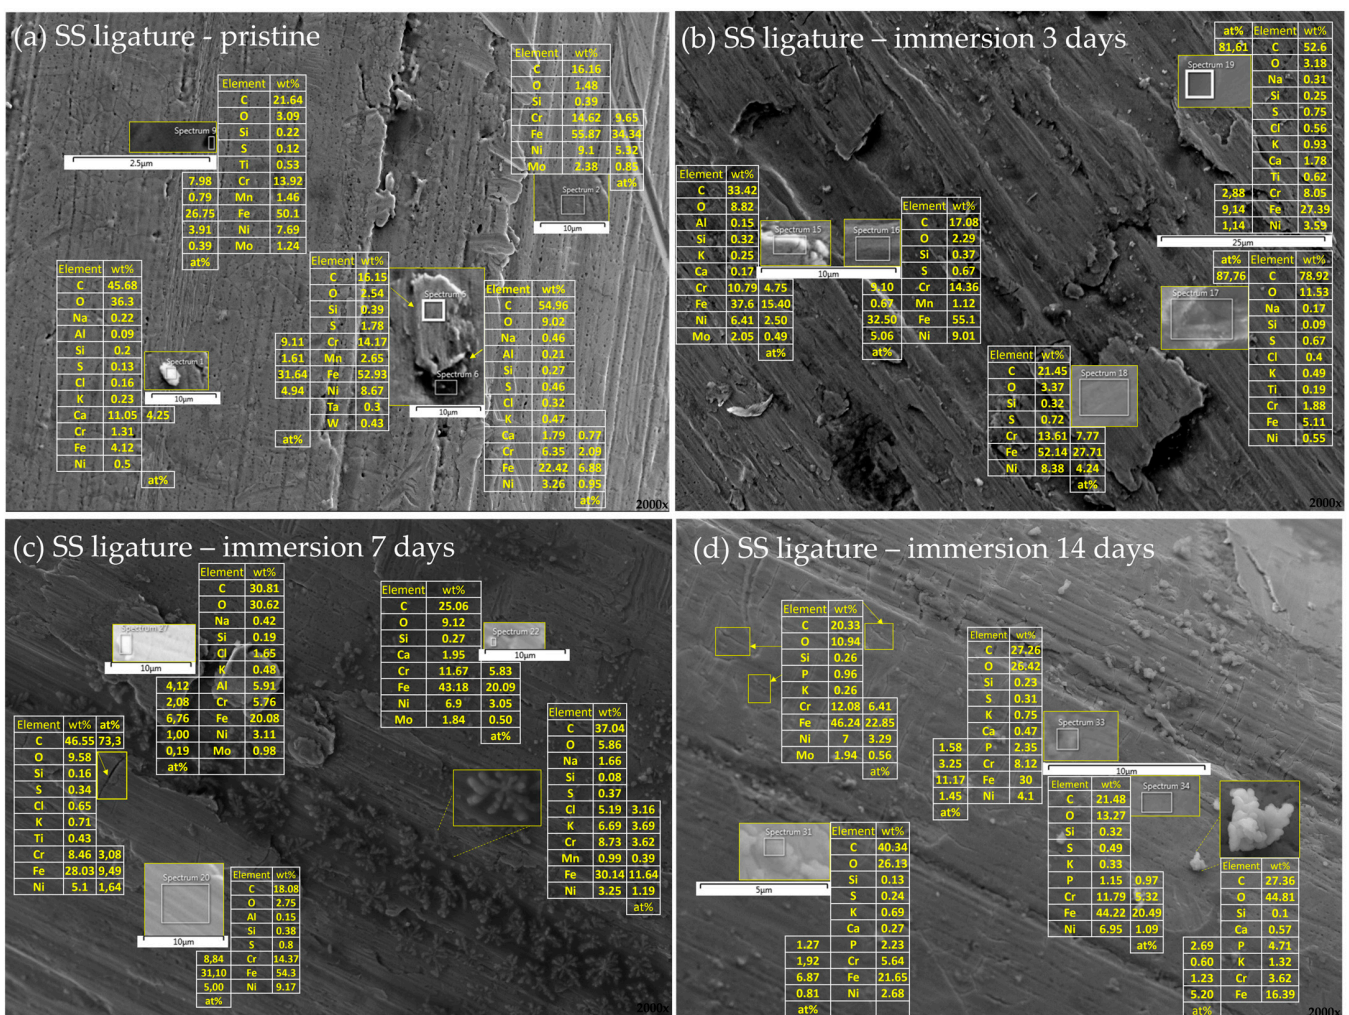
**Figure 8.** Elemental analysis of the ligatures surface in an (a) as-received state and after (b) 3 days, (c) 7 days, and (d) 14 days of immersion in artificial saliva. Smaller images show a magnified view of representative surface areas/deposits/precipitates seen in the background image. The tables next to the smaller images show the respective elemental compositions, expressed as wt% for all the elements and at% for those most relevant. In the right corner of every part of a figure is a magnification.

The elemental composition of the unaffected areas on the surface of the ligatures reflected the composition of the bulk. Ca-rich deposits were again observed, but were now accompanied by increased amounts of C and O, suggesting the formation of calcium carbonate. Compared to the brackets and bands, an increased number of sites containing extraordinary amounts of carbon were observed (sp. 17 and 19, Figure 8b; sp. 6, Figure 8a; etc.), but not in the form of pits as seen on the surface of the brackets (Figure 6b). Crystals with a peculiar morphology were observed in the striation after 7-day immersion (Figure 8c). Alongside the usual bulk elements, the EDX of these crystals showed equimolar amounts of K and Cl, indicating the formation of KCl crystals also on the surface of the ligatures, but—in contrast to KCl-rich deposits on archwires and bands—their morphology on the ligatures was markedly different. A multitude of crystal morphologies has been found for salivary crystals [37], including rectangular, polyhedral, ovoid, and rod-like, with the latter describing well the morphology seen on Figure 8c.

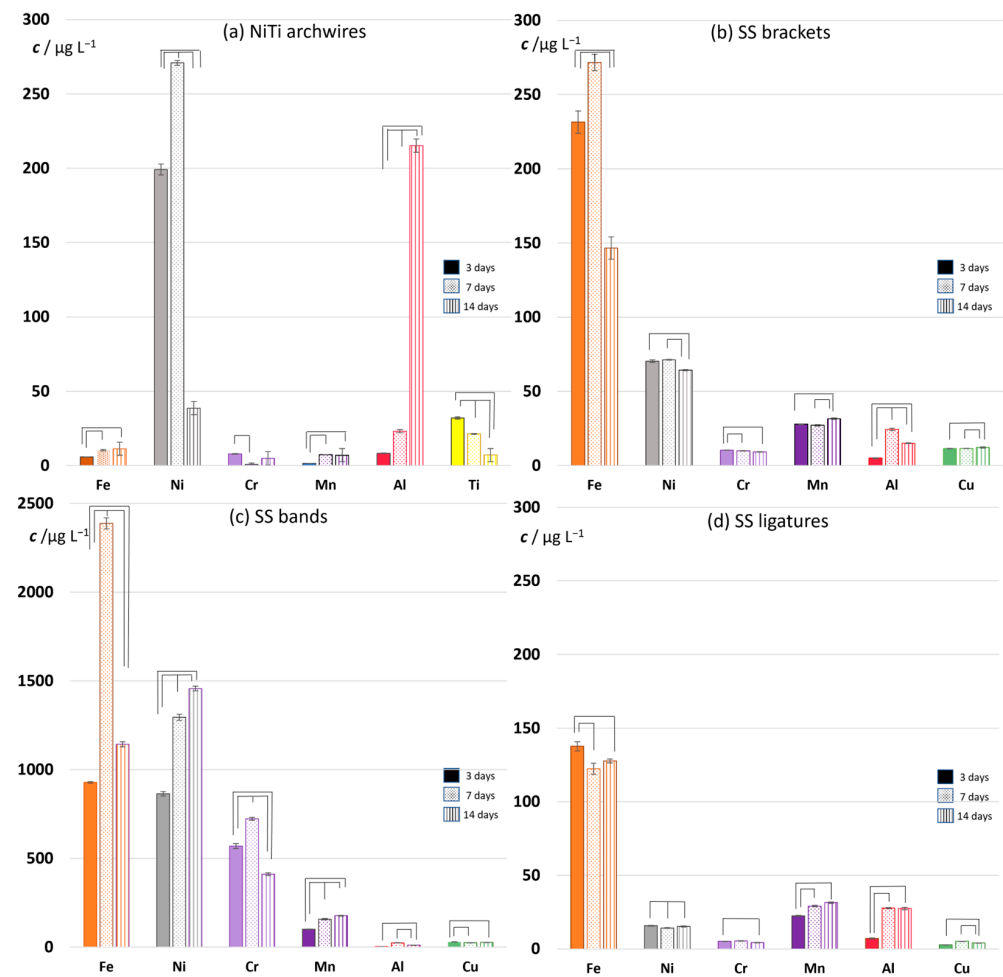
**Figure 9.** The concentrations of the most relevant ions released from (a) NiTi archwires, (b) SS brackets, (c) SS bands, and (d) SS ligatures after 3-, 7-, and 14-day immersion in artificial saliva at 37 °C. The lines/connections associate the metal ion concentrations that differ significantly (ANOVA, Post hoc Tukey HSD test,  $p < 0.05$ ).

The results of metal ion release from NiTi archwires immersed in artificial saliva for 3, 7 and 14 days are shown in Figure 9a. After 3 days, the relative order of eluted concentrations

of the three most abundant elements in the nominal composition was preserved ( $\text{Ni} > \text{Ti} > \text{Fe}$ ), but the relative amounts were not proportional; as expected, the concentration of Ni far exceeded its nominal weight percentage compared to the other ions, similar to findings of Papaionau [20]. Notably, the concentrations of Al, Cr, Zn, Sr, and Rb all exceeded the Fe concentration, even though they were not listed in the nominal composition. EDX analysis indicated the presence of aluminum oxide on the surface of the archwire (Section 3.2.1), which explains the relatively high eluted Al concentration. However, the other elements were not detected at any of the analyzed sites. The non-negligible eluted concentrations of Mn, Cu, Mo, Ba, and Pb ions were also measured (Supplementary Materials Table S1).

From day 3 to day 7, the concentrations of all the elements increased, except those of Ti and Cr. By day 7, the Ti and Cr concentrations decreased by one-third and by an order of magnitude, respectively. With further immersion, a seemingly erratic trend in concentration change could be observed, and the trends differed for each element. This kind of erratic behavior has been reported in other studies [61]. The concentrations of some elements reached a maximum on day 7, most notably Ni. A pronounced maximum observed for Ni after 7-day immersion is consistent with previous studies [65,66], although divergent results have also been reported [8]. While Ni concentration drastically decreased by day 14, Al concentration markedly increased. The increase throughout the whole measurement

For all SS appliances (Figure 9b–d), Fe was the most abundant of the eluted ions, as expected. After 3 days of immersion, the relative order of eluted concentrations of the four most abundant elements in the nominal composition ( $\text{Fe} > \text{Cr} > \text{Ni} > \text{Mn}$ ) was not maintained, nor were their relative amounts. Namely, Ni was detected in higher concentrations than Cr, consistent with the literature [20,67]. While an increase in eluted concentrations of all the elements apart from Ti and Cr were observed for NiTi wires from day 3 to day 7, a corresponding trend was observed only for the bands among the SS parts of the appliance. For most elements eluted from the brackets and ligatures, the values stagnated or slightly decreased during the same period. For ligatures, even the Fe concentration was lower after 7-day immersion. The trends of Ni were different for the individual parts of the appliance: a significant increase throughout the measurement period for the bands, stagnation for the ligatures, and a slight decrease on day 14 for the brackets.

Figure 9 showed the eluted concentrations of the most relevant ions, not the most abundant ones. Data for all the eluted ions for each part of appliance are given in Supplementary Materials Table S1. High concentrations of certain ions can be observed, namely, calcium, rubidium, and zinc. These ions originate from the artificial saliva itself, as shown in Figure 10a, and were therefore excluded from data shown in Figure 9.

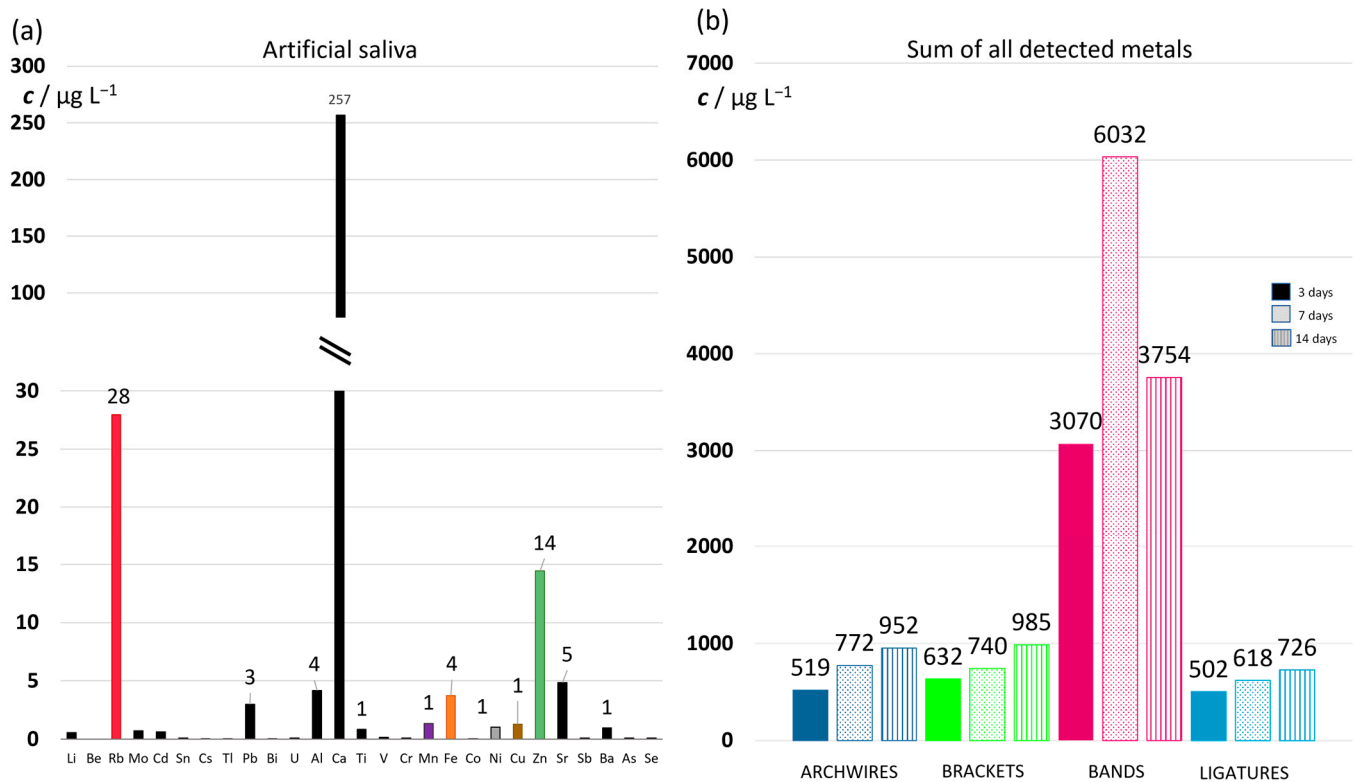
**Figure 10.** (a) The concentrations of the most abundant ions found in artificial saliva; (b) the sum of concentrations of all detected metals in archwires, brackets, bands, and ligatures after 3-, 7-, and 14-day immersion in artificial saliva at 37 °C.

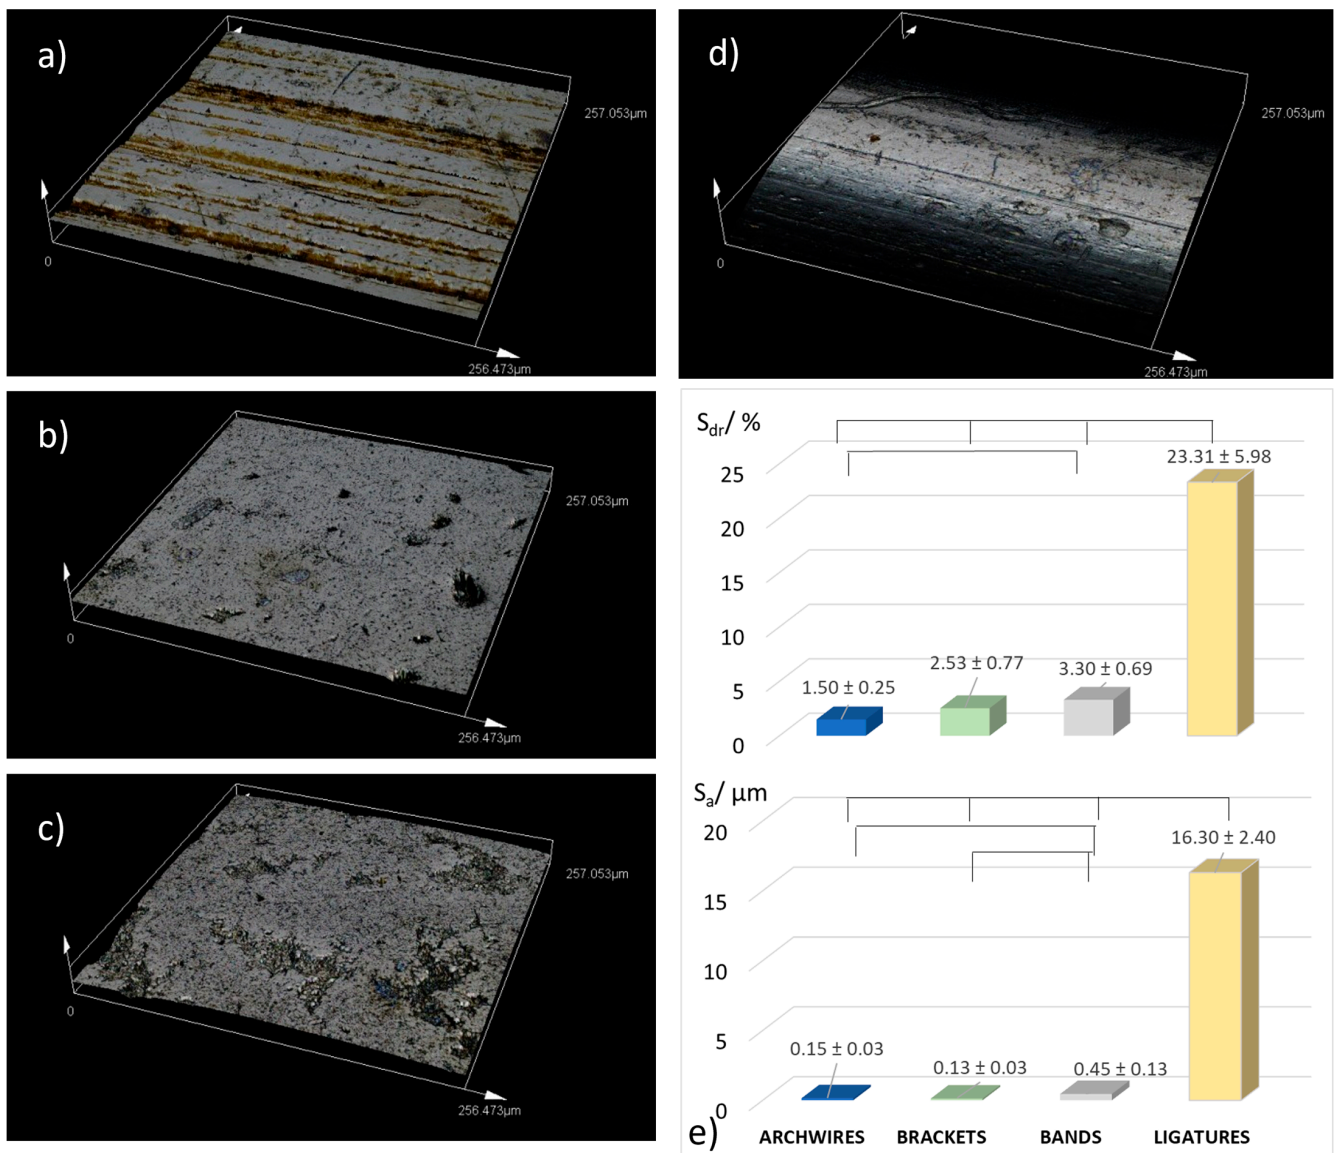
**Figure 11.** Representative CLMX images of (a) NiTi archwires, (b) SS brackets, (c) SS bands, and (d) SS ligatures, after 7-day immersion in artificial saliva. Surface roughness (e) is given as arithmetic mean surface roughness,  $S_a$ , and the developed interfacial area ratio,  $S_{dr}$ . The lines/connections associate the surface roughness values that differ significantly (Mann–Whitney U test,  $p < 0.05$ ).

The  $S_{dr}$  parameter revealed that the surface roughness is significantly higher for the ligatures compared to all other appliances. The ordering based on surface roughness showed no correlation with the eluted ion concentrations (Figure 10b). The ligatures, with the highest surface roughness, released on average the lowest amounts of ions. The bands, which released excessively high amounts of ions, had roughness similar to that of wires and brackets, and significantly lower roughness than ligatures. Such results imply that, in

accordance with the majority of literature data, for our samples the surface roughness was not correlated to the amount of released ions.
