*Source / Izvornik:* **Materials, 2023, 16**

**Journal article, Published version**

# Cytotoxicity of Metal Ions Released from NiTi and Stainless Steel Orthodontic Appliances, Part 1: Surface Morphology and Ion Release Variations

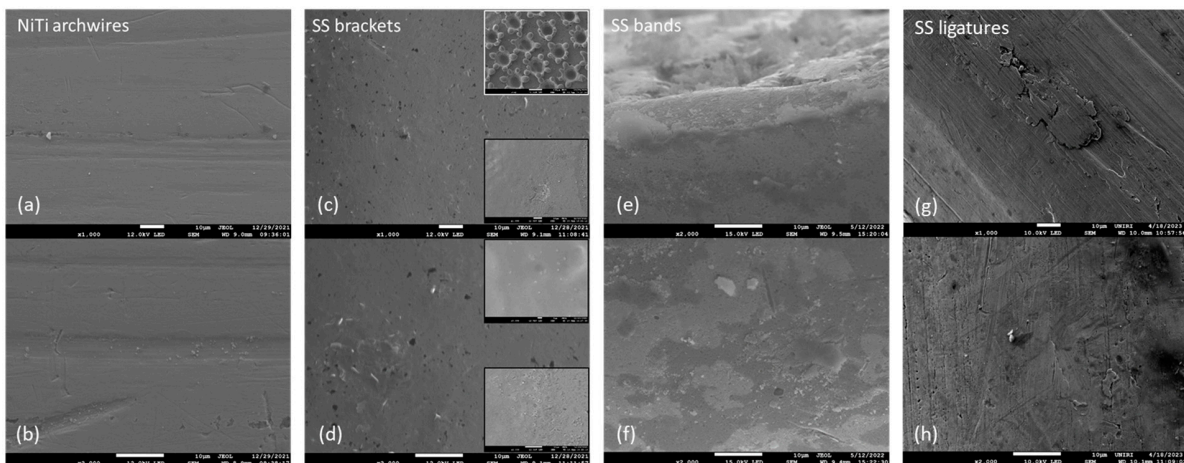
**Figure 2.** Representative lower magnification (top row) and higher magnification (bottom row) SEM micrographs of (a,b) NiTi archwires, (c,d) stainless steel brackets (SS), (e,f) SS bands, and (g,h) SS ligatures, after 3 days of immersion in artificial saliva.

Three days of immersion did not notably enhance the pitting corrosion in SS brackets, nor did it result in deposits or adherent material. However, the protrusion of crystal clusters from the bulk was observed. Higher magnification images (representative image given as upper addendum in Figure 2d) further indicated that the small white entities were not the adhering material. Besides those, the lower bracket surface, containing areas of various morphologies (addendums in Figure 2c,d), also showed no notable changes.

On the contrary, the SEM micrographs of SS bands (Figure 2e,f) showed prominent changes and a very small portion of the unaffected surface. Most of the surface was covered with an adherent layer that was not detected on other parts of the fixed appliance. This layer can be recognized as an oxide protective layer, which is common on SS products [30–33]. Lighter colored deposits were observed on the top of the protective layer and in the areas in between, which were reminiscent of layer debris [34].

Black pits were visible on the surface of SS ligatures (Figure 2g,h), indicating the onset of corrosion. An increased number of white crystal precipitates was also observed.

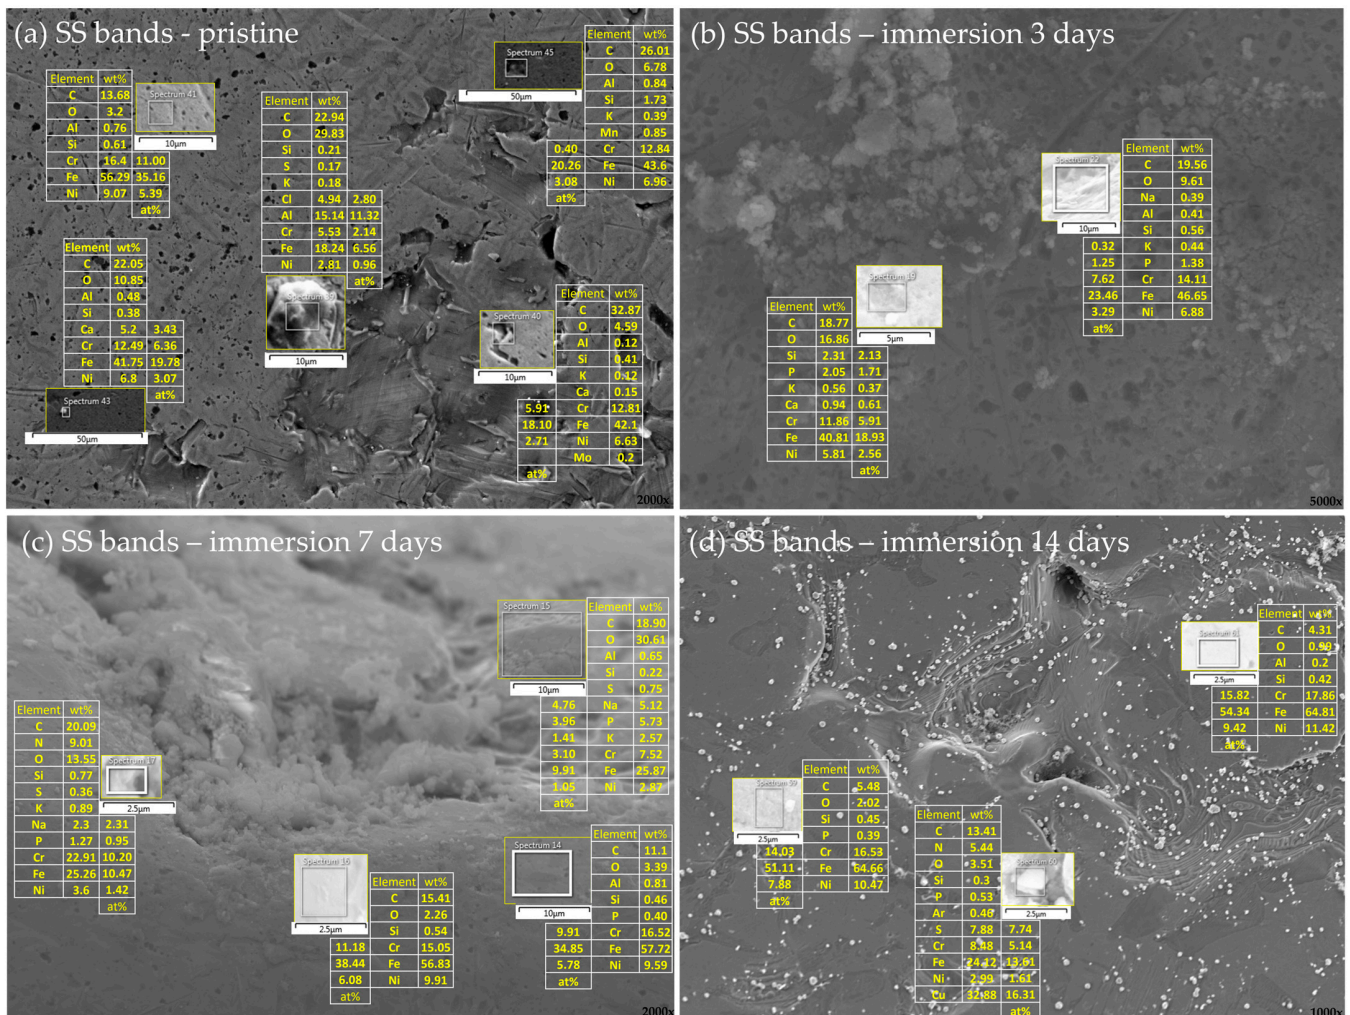
**Figure 7.** Elemental analysis of the band's surface in an (a) as-received state and after (b) 3 days, (c) 7 days, and (d) 14 days of immersion in artificial saliva. Smaller images show a magnified view of representative surface areas/deposits/precipitates seen in the background image. The tables next to the smaller images show the respective elemental compositions, expressed as wt% for all the elements and at% for those most relevant. In the right corner of every part of a figure is a magnification.

immersion in AS, cannot be rejected. Similar results were obtained for the SS bands in the pristine state (Figure 7a).

EDX analysis of the bands after immersion revealed higher amounts of oxygen compared to the brackets, indicating the formation of an oxide layer, which is consistent with the results of qualitative SEM analysis. The Al-rich deposits were also found (e.g., sp. 39, Figure 7a), but—contrarily to NiTi archwires and SS brackets—no KCl precipitates were observed. Small amounts of Ca-rich entities were found (e.g., sp. 43, Figure 7a), which might occur due to physical adsorption of calcium ions to the oxide layer [62]. An increased quantity of phosphorous atoms was observed, which could indicate the formation of phosphate deposits, which were not observed on archwires and brackets.

EDX analysis further disclosed the presence of metals not listed in the nominal composition of the bands, namely Cu (sp. 60, Figure 7d). A plausible explanation for the presence of copper might be found in the fact that Cu is a component of silver solder alloy, which is still the most commonly used soldering alloy in orthodontics [63,64]. Note that the SS bands are made of SS 1.4303 and SS 1.4551, with the latter being the filler metal. Copper(II) phosphate deposits were observed by Wendl et al. [8] on the bands with attachments from the same manufacturer.

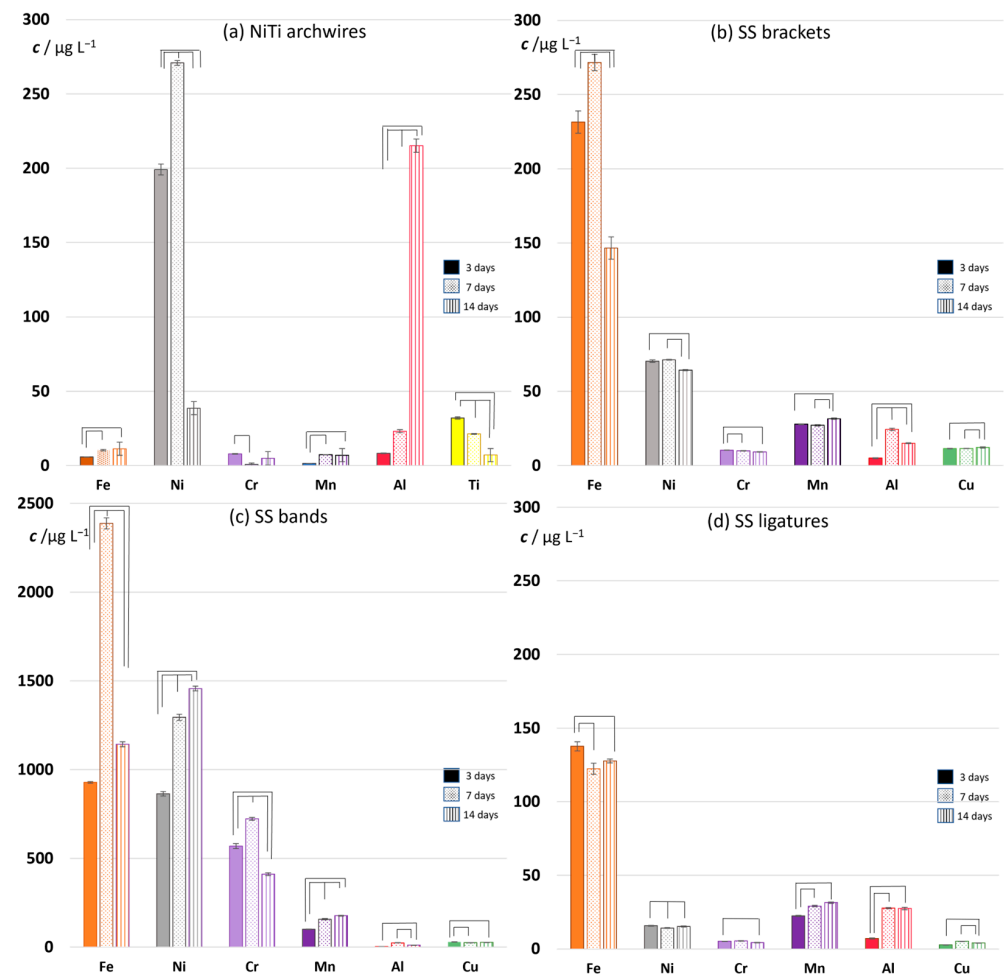
**Figure 9.** The concentrations of the most relevant ions released from (a) NiTi archwires, (b) SS brackets, (c) SS bands, and (d) SS ligatures after 3-, 7-, and 14-day immersion in artificial saliva at 37 °C. The lines/connections associate the metal ion concentrations that differ significantly (ANOVA, Post hoc Tukey HSD test,  $p < 0.05$ ).

The results of metal ion release from NiTi archwires immersed in artificial saliva for 3, 7 and 14 days are shown in Figure 9a. After 3 days, the relative order of eluted concentrations

of the three most abundant elements in the nominal composition was preserved ( $\text{Ni} > \text{Ti} > \text{Fe}$ ), but the relative amounts were not proportional; as expected, the concentration of Ni far exceeded its nominal weight percentage compared to the other ions, similar to findings of Papaionau [20]. Notably, the concentrations of Al, Cr, Zn, Sr, and Rb all exceeded the Fe concentration, even though they were not listed in the nominal composition. EDX analysis indicated the presence of aluminum oxide on the surface of the archwire (Section 3.2.1), which explains the relatively high eluted Al concentration. However, the other elements were not detected at any of the analyzed sites. The non-negligible eluted concentrations of Mn, Cu, Mo, Ba, and Pb ions were also measured (Supplementary Materials Table S1).

From day 3 to day 7, the concentrations of all the elements increased, except those of Ti and Cr. By day 7, the Ti and Cr concentrations decreased by one-third and by an order of magnitude, respectively. With further immersion, a seemingly erratic trend in concentration change could be observed, and the trends differed for each element. This kind of erratic behavior has been reported in other studies [61]. The concentrations of some elements reached a maximum on day 7, most notably Ni. A pronounced maximum observed for Ni after 7-day immersion is consistent with previous studies [65,66], although divergent results have also been reported [8]. While Ni concentration drastically decreased by day 14, Al concentration markedly increased. The increase throughout the whole measurement

For all SS appliances (Figure 9b–d), Fe was the most abundant of the eluted ions, as expected. After 3 days of immersion, the relative order of eluted concentrations of the four most abundant elements in the nominal composition ( $\text{Fe} > \text{Cr} > \text{Ni} > \text{Mn}$ ) was not maintained, nor were their relative amounts. Namely, Ni was detected in higher concentrations than Cr, consistent with the literature [20,67]. While an increase in eluted concentrations of all the elements apart from Ti and Cr were observed for NiTi wires from day 3 to day 7, a corresponding trend was observed only for the bands among the SS parts of the appliance. For most elements eluted from the brackets and ligatures, the values stagnated or slightly decreased during the same period. For ligatures, even the Fe concentration was lower after 7-day immersion. The trends of Ni were different for the individual parts of the appliance: a significant increase throughout the measurement period for the bands, stagnation for the ligatures, and a slight decrease on day 14 for the brackets.

Figure 9 showed the eluted concentrations of the most relevant ions, not the most abundant ones. Data for all the eluted ions for each part of appliance are given in Supplementary Materials Table S1. High concentrations of certain ions can be observed, namely, calcium, rubidium, and zinc. These ions originate from the artificial saliva itself, as shown in Figure 10a, and were therefore excluded from data shown in Figure 9.
